PRE-PURCHASE ASSESSMENT  
**PRELIMINARY REPORT**  
MV SINOTECH MARINE  
(BULK CARRIER)

IMO NO.	1234567
Port of Registry	LIBERIA
Year of Built	30/07/2010
Builder Yard	HYUNDAI MIPO DOCKYARD CO LTD
Classification	LLOYDS REGISTER
Vessel State	PORTSIDE ALONGSIDE, DISCHARGING
Date of Inspection	21-22 JAN 2020
Port of Inspection	SAMALAJU, MALAYSIA
Inspection Company	SINOTECH MARINE
Inspection Type	PRE- PURCHASE INSPECTION
Client	CONFIDENTIAL

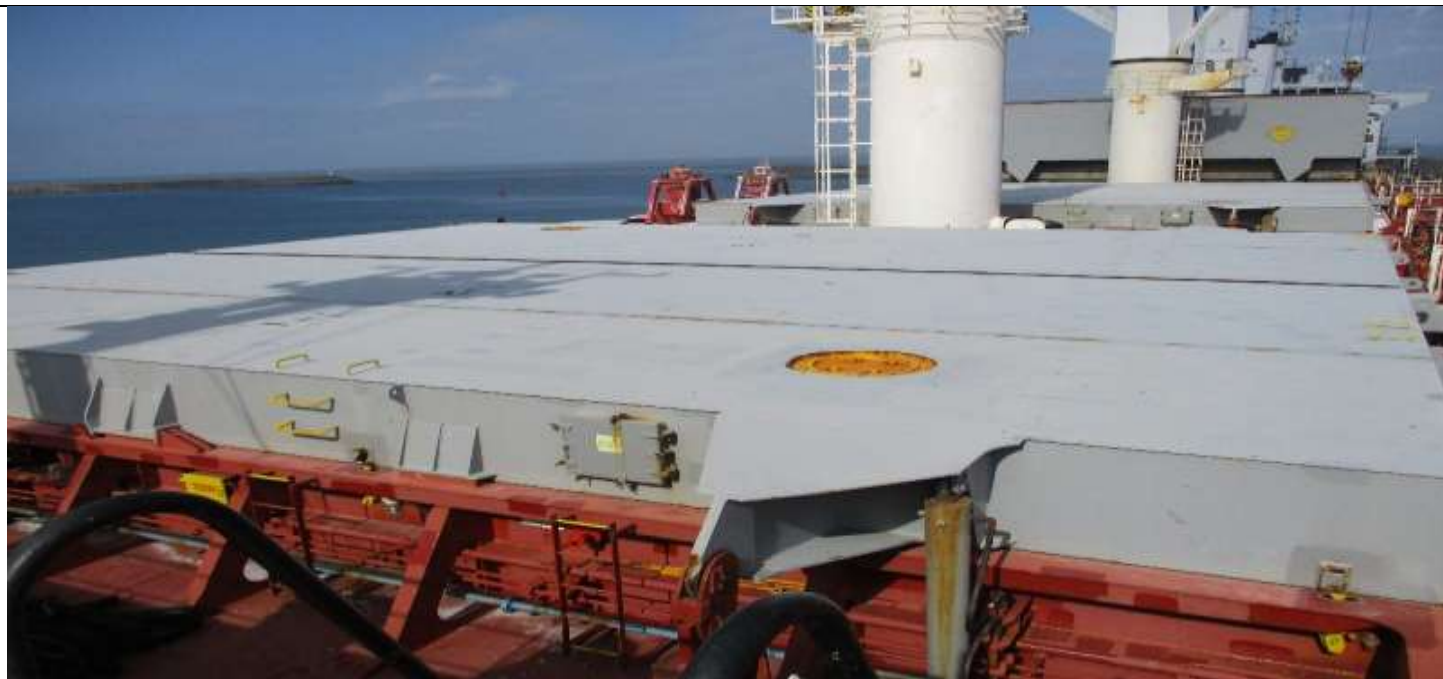
**HATCH COVER TOP**

- 1- Vessel is not fitted with the BWTS as required by D2 compliance. The due date for the installation is 3<sup>rd</sup> Jan 2021, during second special, renewal of IOPP certificate.
- 2- Vessel is close to 2<sup>nd</sup> special survey in less than 1 year.
- 3- Hull external has some coating loss but not a major concern as ship will be going for docking within a year.
- 4- Vessel is not fitted with Exhaust cleaning Scrubber; compliant fuel is the only option.
- 5- On main deck found isolated rust and paint coating loss to be addressed. A continuous deck maintenance would be required by the crew.
- 6- Spot rust on the hatch covers and channels found. Underside of the hatch covers found with spot rust.

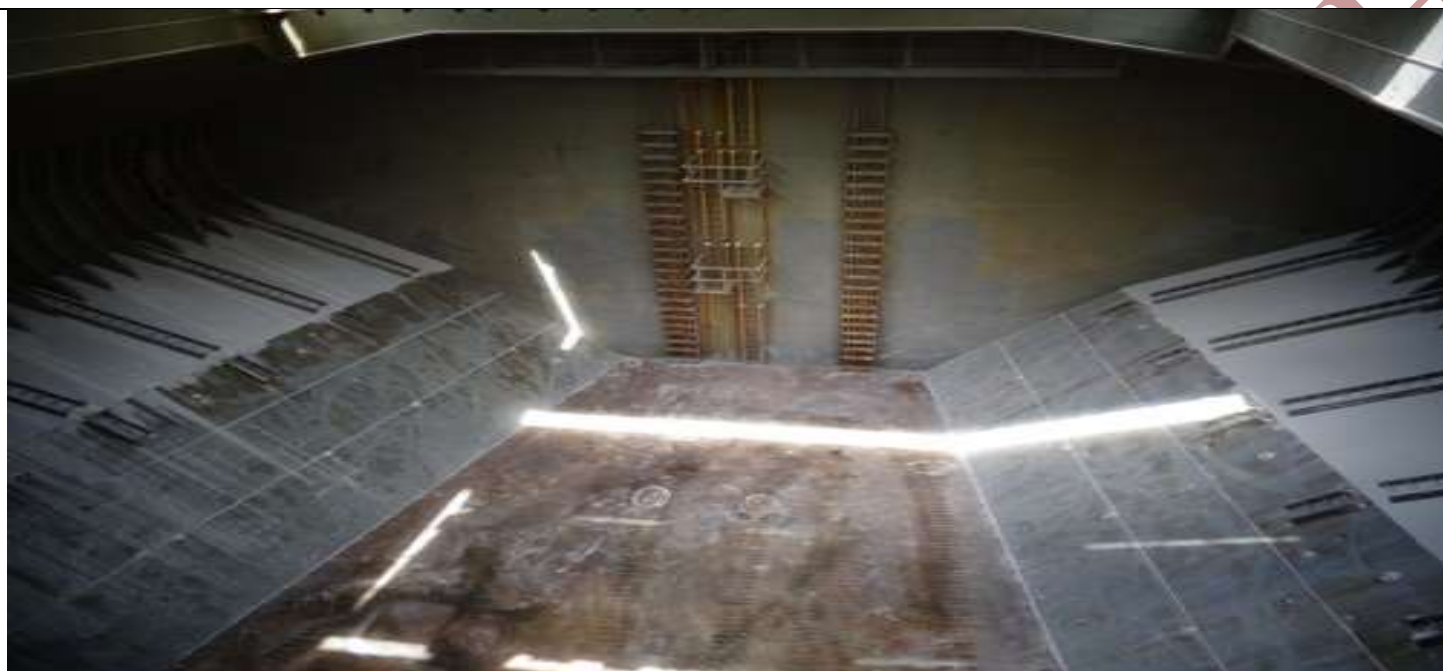
**CARGO HOLD FROM TOP**

7	Cargo Holds	Yes	Light damages of Grab marks on the tank tops and side tank bulkheads.
8	Ballast Tanks & Void spaces	Yes	Some air pockets and erection joints have paint failures. Some grab bumps on DB tank top parts made paint cracks. No cracks on steel plate.
9	Accommodation	No	
10	Bridge & Monkey Island	No	
11	Engine Compartment	No	
12	Steering Compartment	No	
13	Vents & Sounding Pipes	Yes	FO tank vents have rusty appearances.
14	Funnel & Flaps	No	
15	Mushroom Vents,	No	
16	Port holes, Ventilators	Yes	Moderate rust on portholes
