PRE-PURCHASE ASSESSMENT

FINAL REPORT

TANKER (OIL/CHEMICAL)

MT SINOTECH MARINE

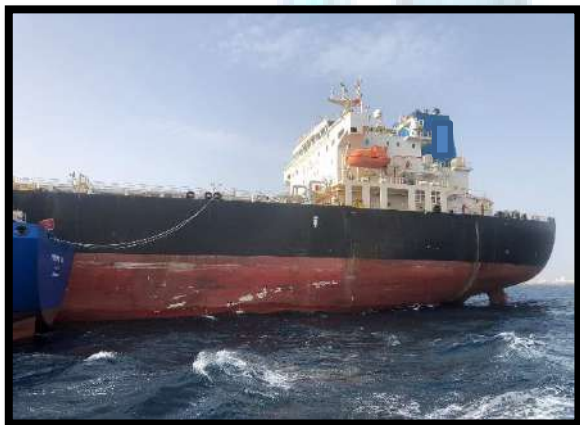
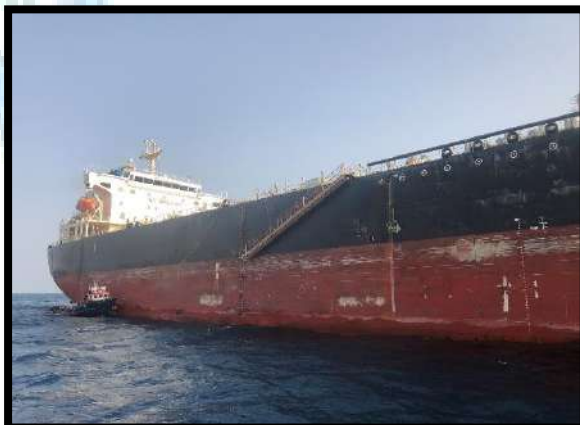
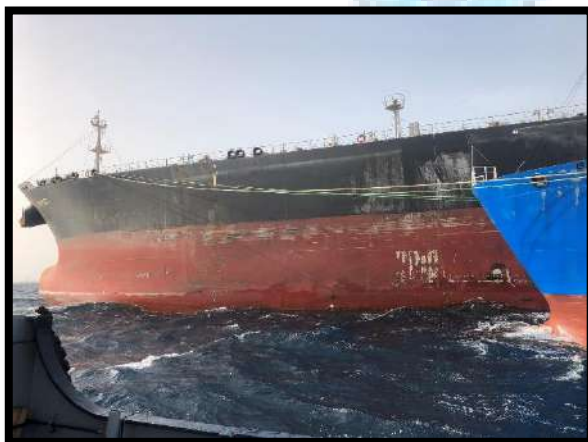
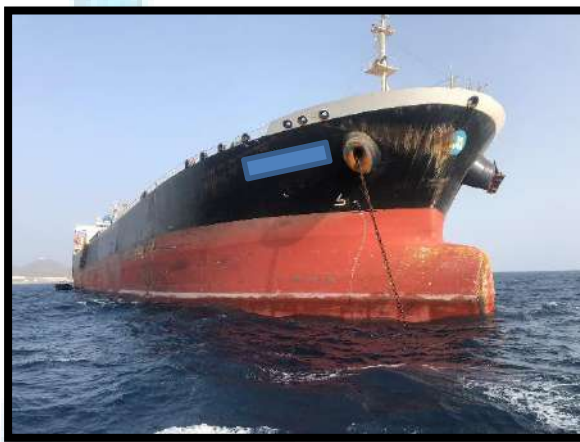
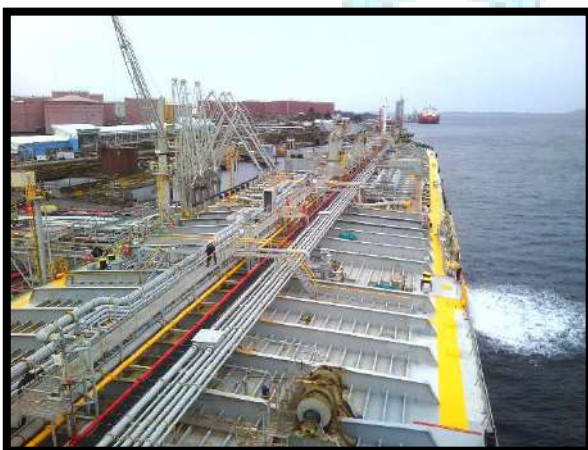
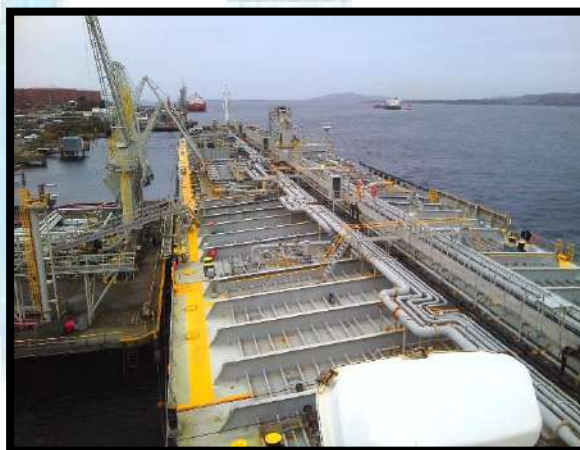
Hull External

- Vessel hull seems in satisfactory condition, a multiple load line assigned for the vessel but only one load line marking permanently applied.

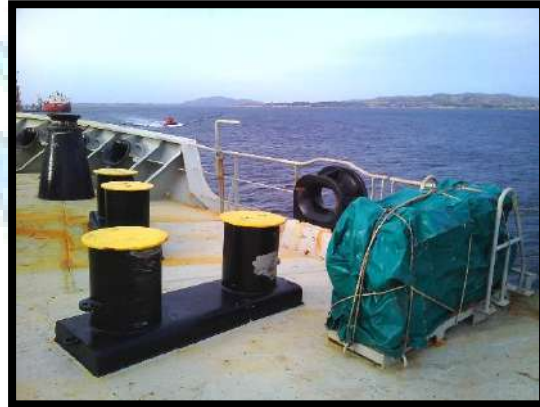
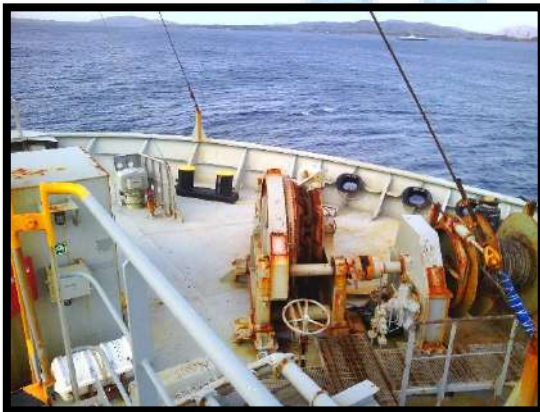
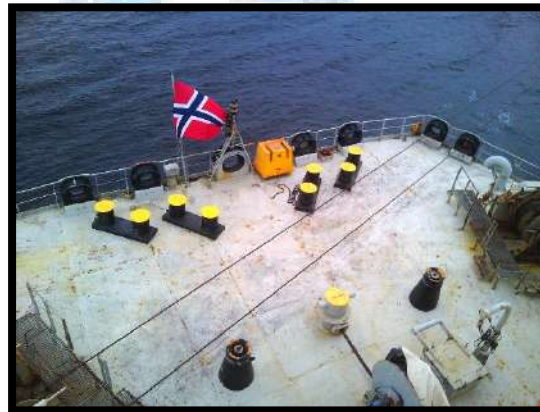
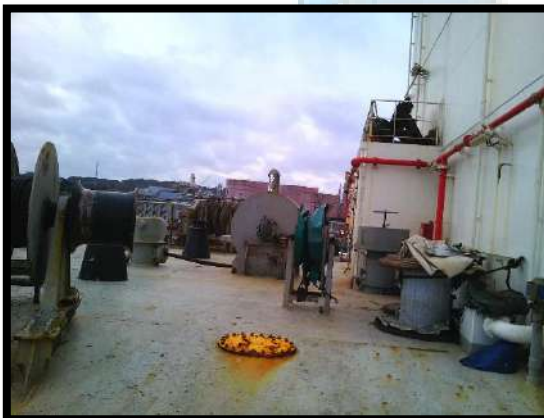
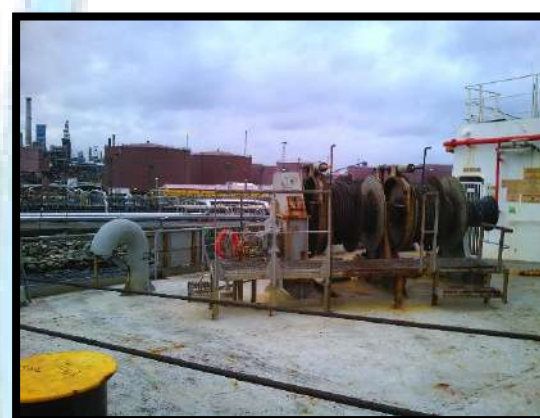
Forecastle & Poop Deck

- Mooring arrangement and deck coating have loose rust, but last maintenance have been not done accordingly

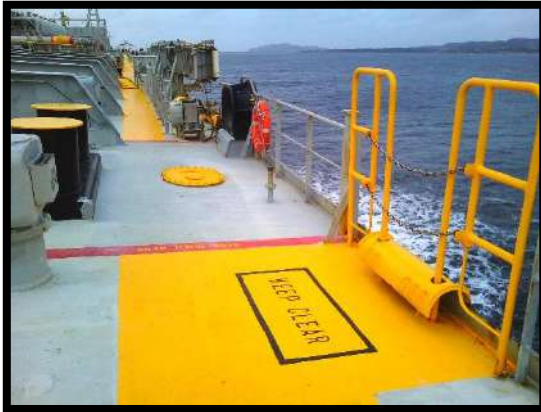
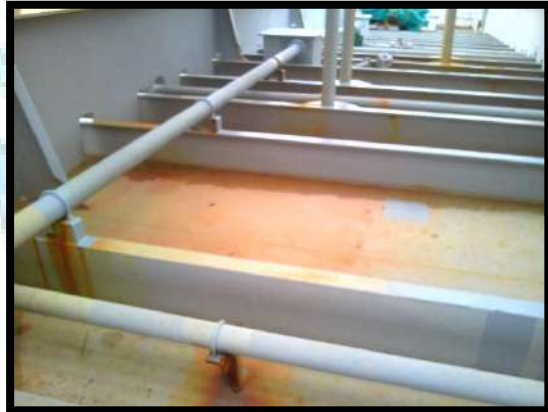
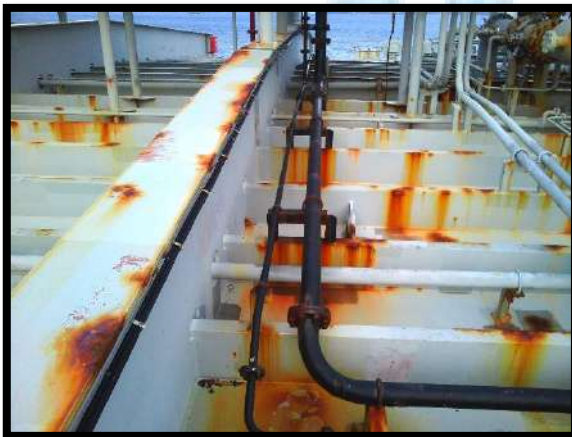
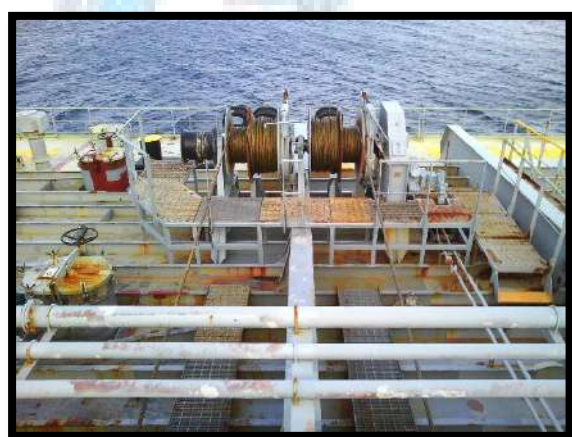
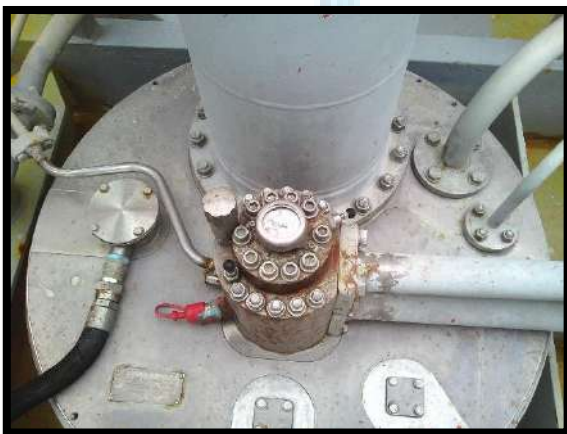
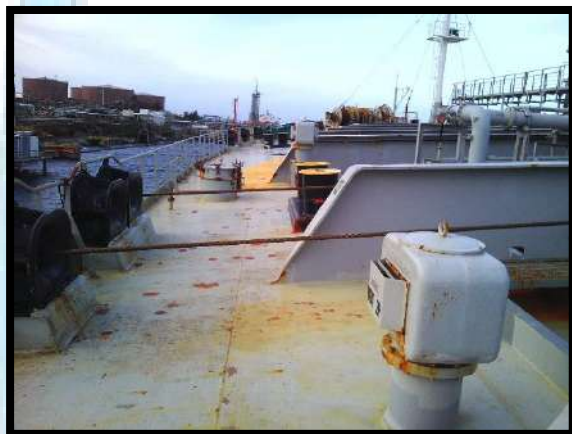
Main Deck & Fittings

- Some manholes have missing bolts. Deck remain lack of maintenance and last paint applied on deck was unsatisfactory

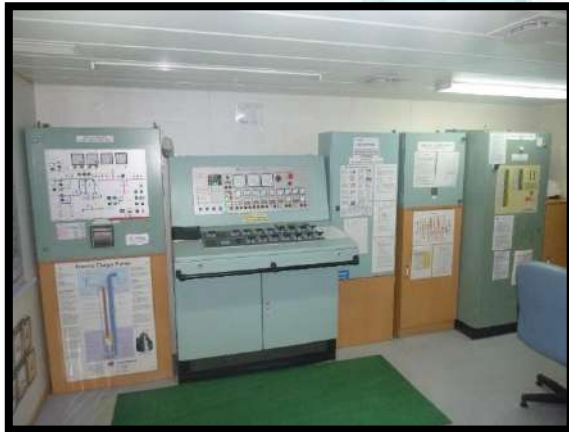
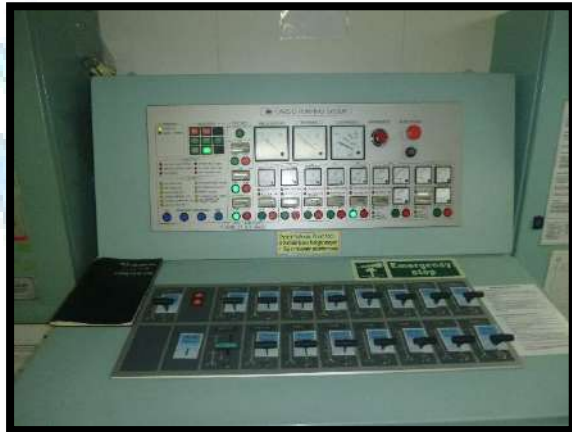
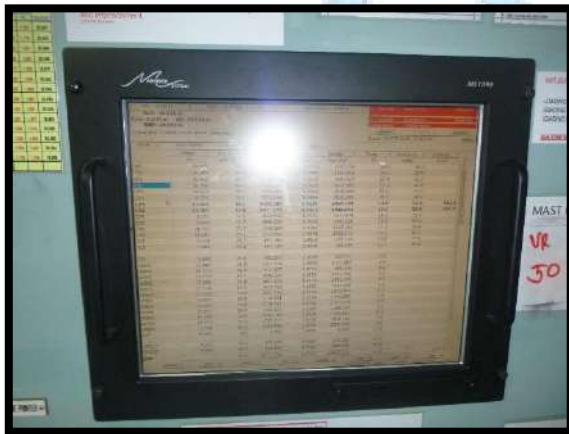
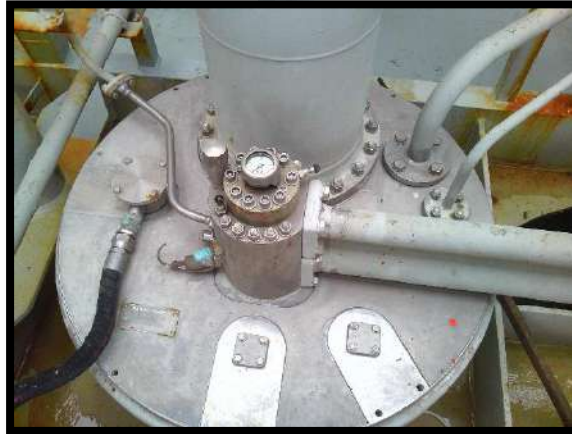
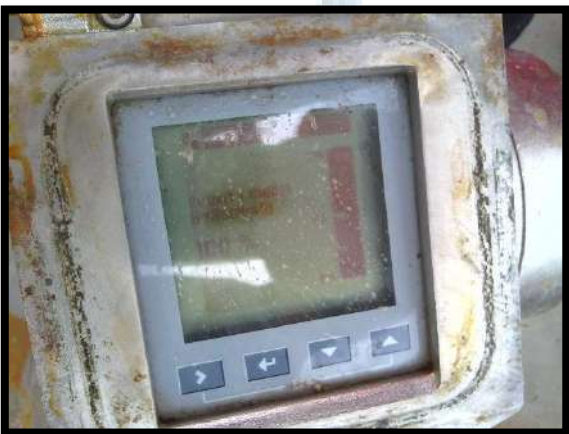
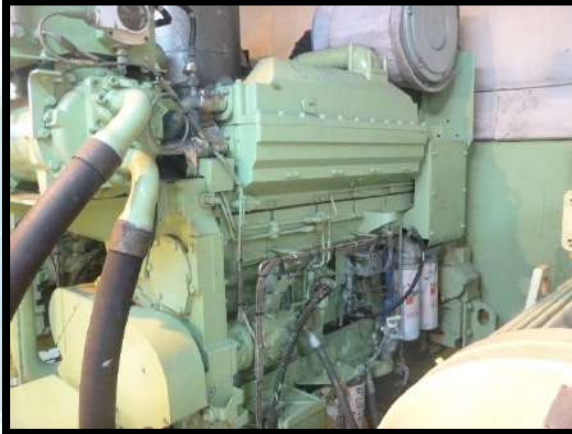
Cargo Control Room & Cargo Pumping System

- Vessel documentation on cargo pump appears in good condition. apparently pumping system have no issues. only, no.4 starboard side tank cleaning heater flange was leaking water

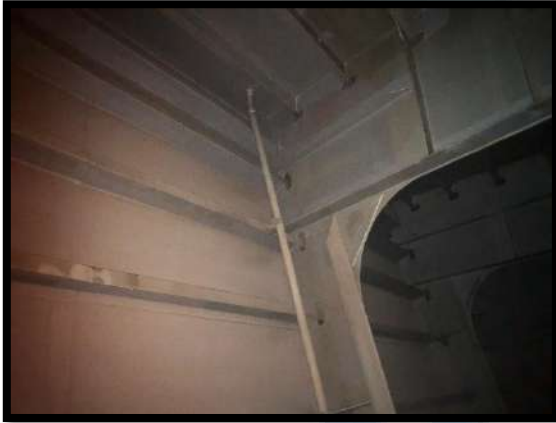
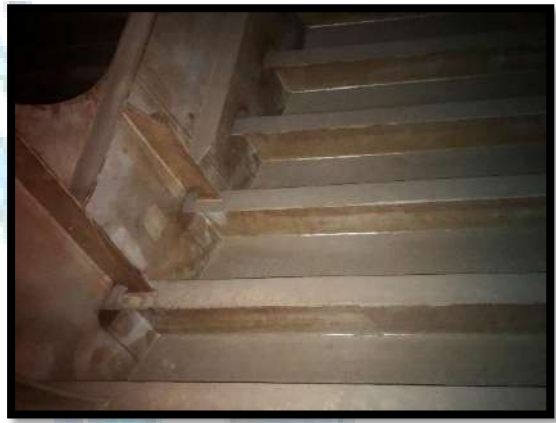
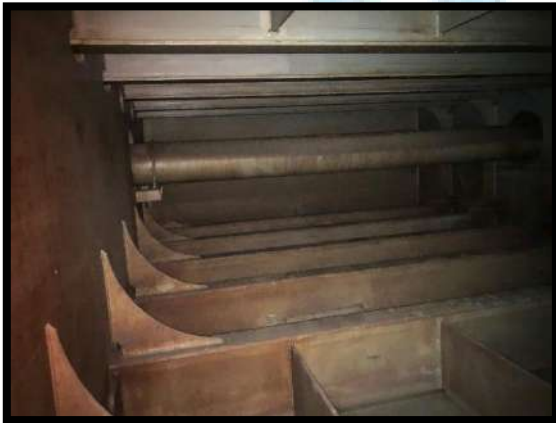
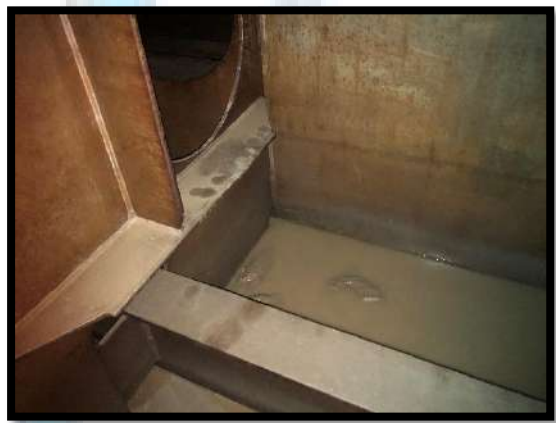
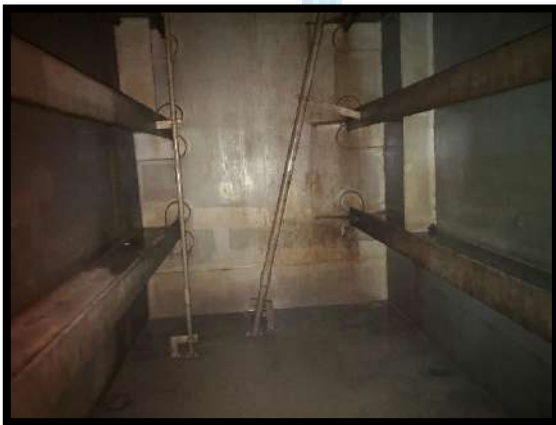
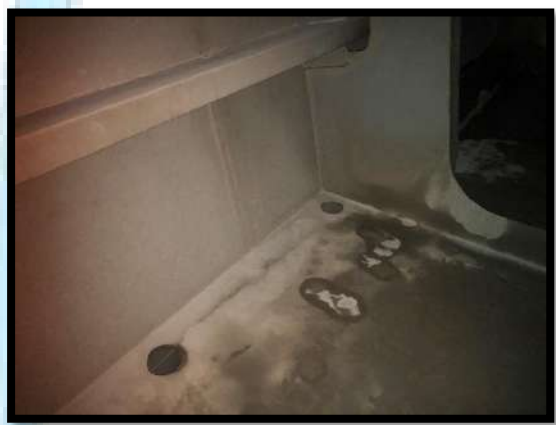
Ballast Tanks

- Vessel have de-harmonization, but subject to BWTS until 26 May 2022. it is projected that there is enough place in engine room, bilge floor. ballast tanks are 'I' shaped. during the inspection, we had chance to inspect 1s wing - DBT and 3 p wing - DBT tanks. tanks are in good condition; a major upgrade have been done during last maintenance. anodes were fully intact but there was some pitting on stiffeners.

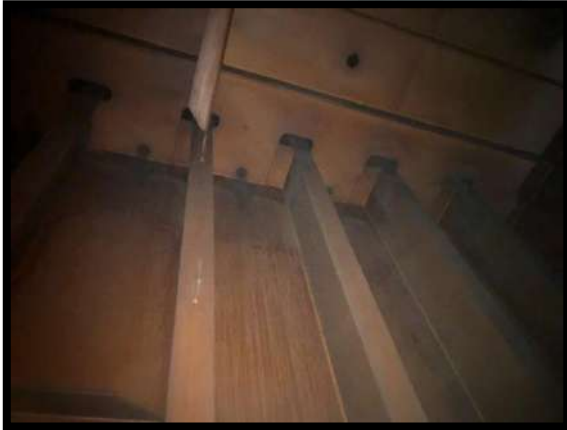
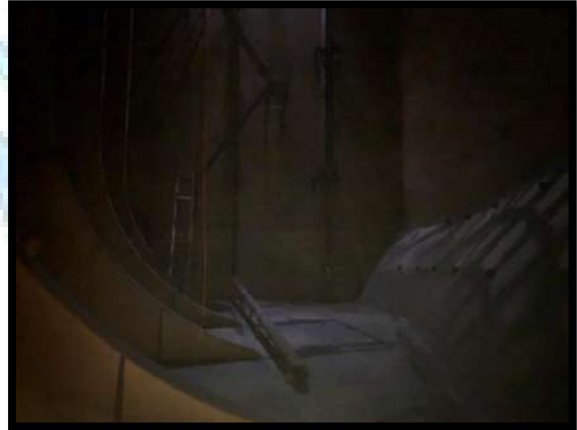
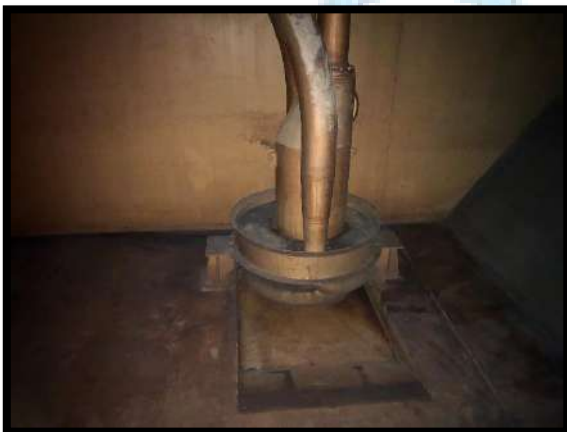
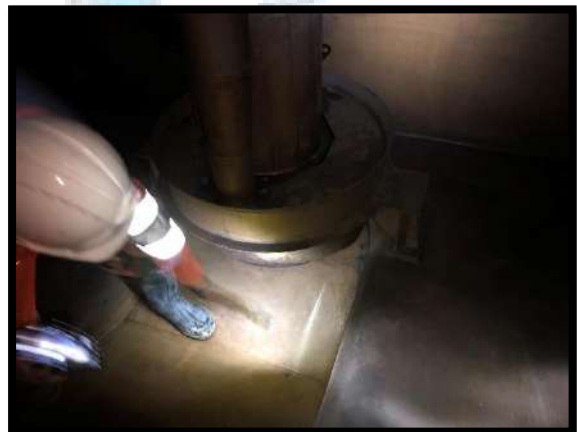
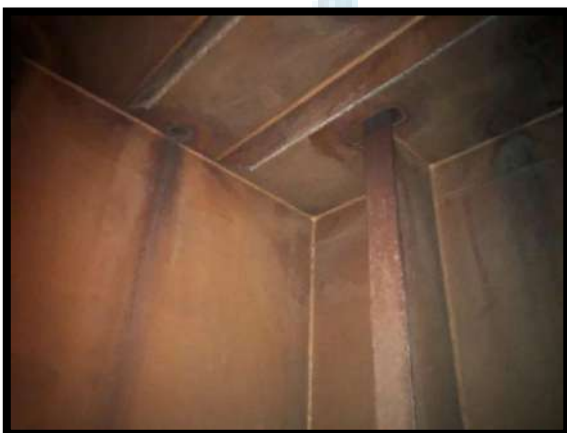
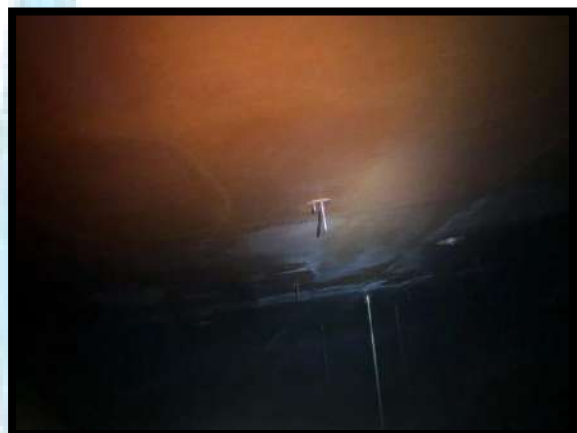
Cargo Tanks

- According to tank inspection reports and few photos obtained from owners, cargo tanks are in satisfactory condition. cargo tanks have no heating system. only fitted with tank cleaning heater. tank cleaning machine have one nozzle only

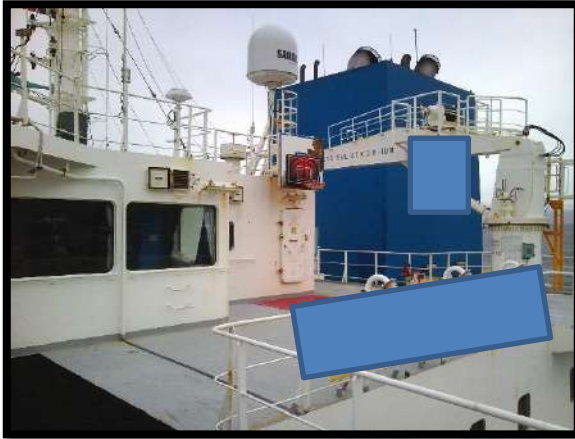
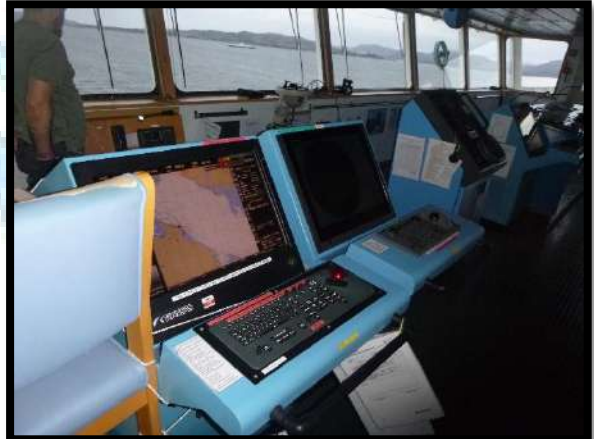
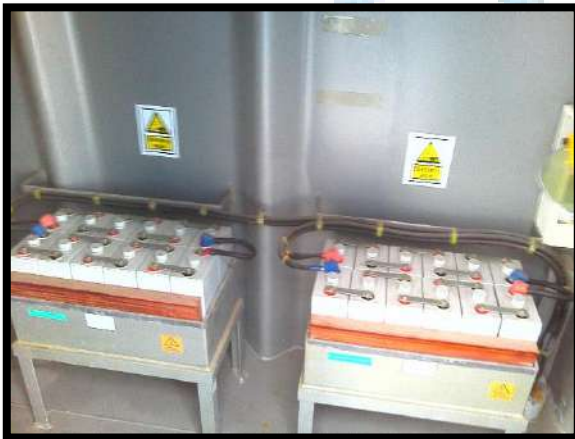
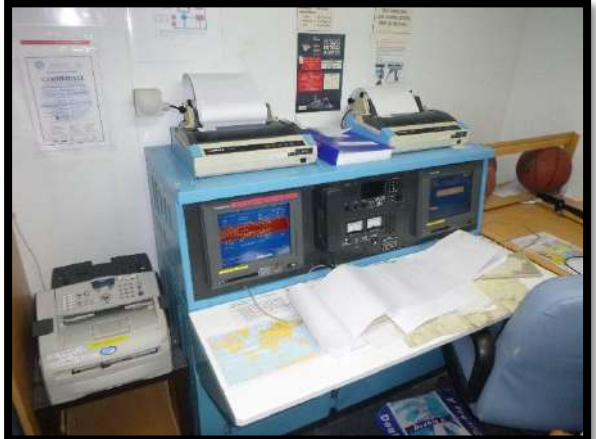
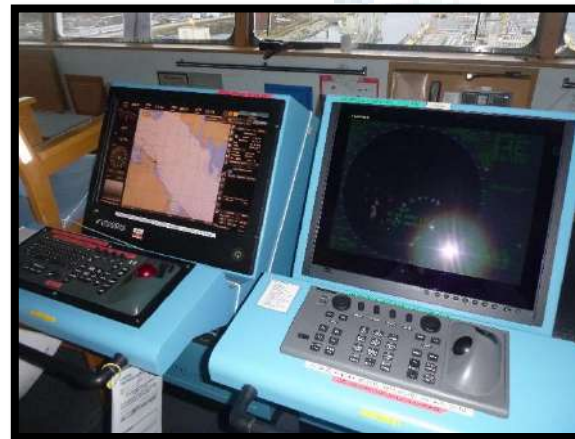
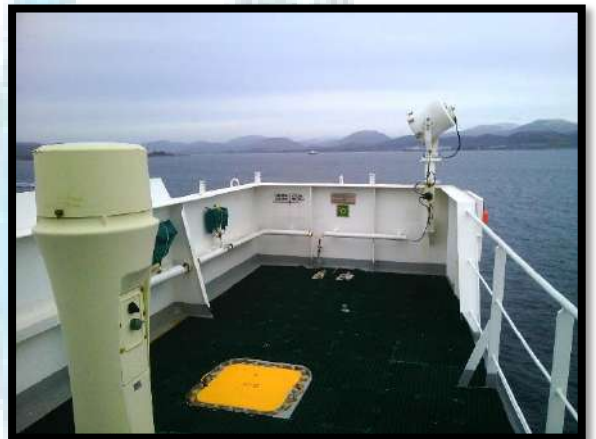
Bridge & Funnel

- Bridge generally found in clean condition and majority of equipment seen as working in order.

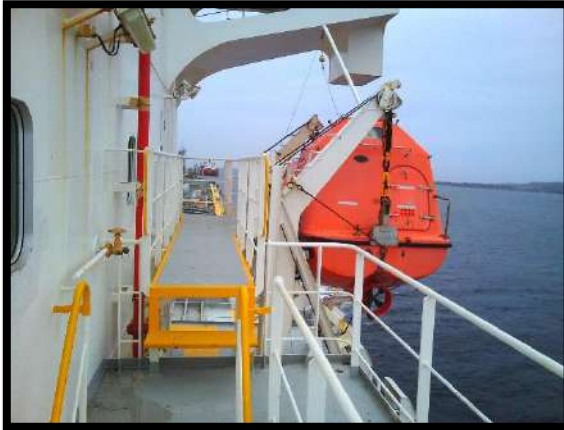
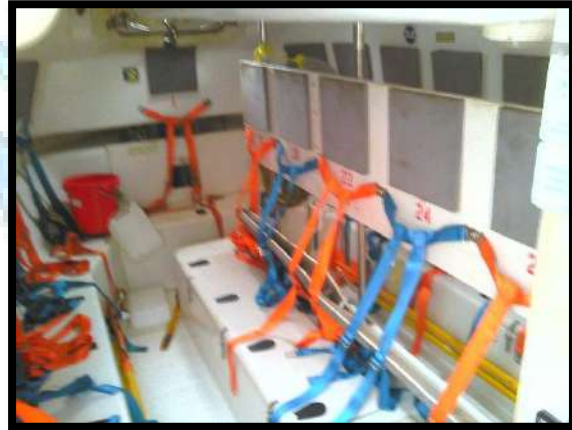
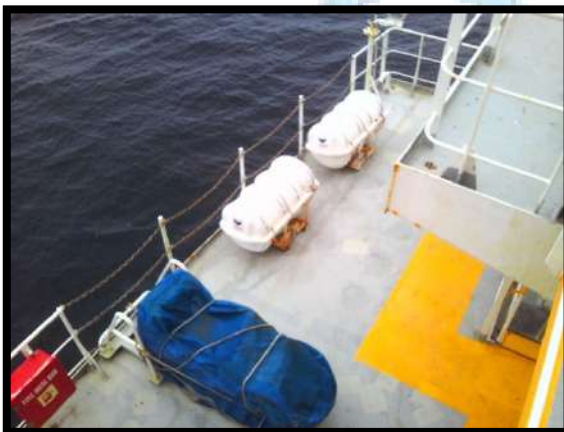
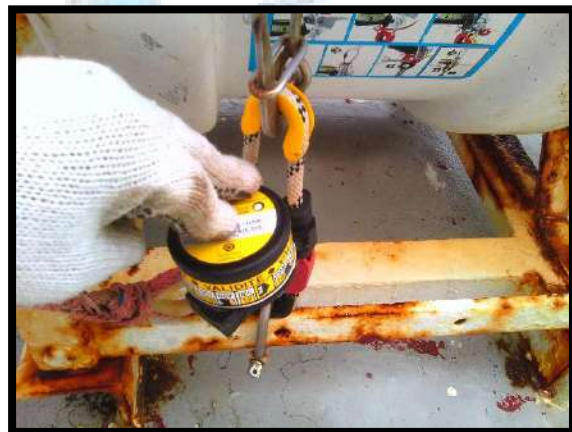
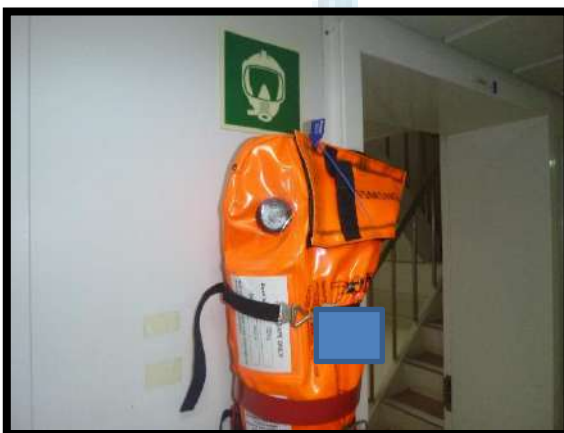
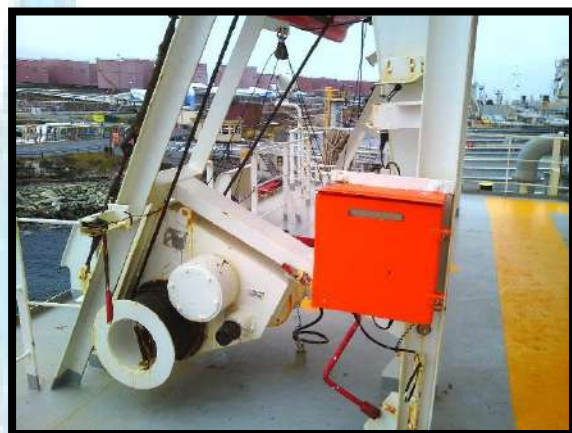
LSA & FFA

- LSA random checked and in good visual condition. there is one breathing apparatus compressor located in engine room. safety certificates are in order.

- Few hydrostatic tests for portable extinguishers are overdue. last calibration for fixed LEL detector not marked on equipment. vessel have additional ex-proof UHFS for fireman outfit
