PART B-CONDITION ASSESMENT REPORT VESSEL: MV SINOTECH MARINE CONTAINER VESSEL

PRE- PURCHASE INSPECTION REPORT

Container ship Portugal Flagged, was accessed by appointed surveyor, from 10:06 LT to 19:30 LT on 21 July 2018 to assess the condition for Pre-purchase evaluation, while she was discharging of Cargo at Sagunto, Spain.

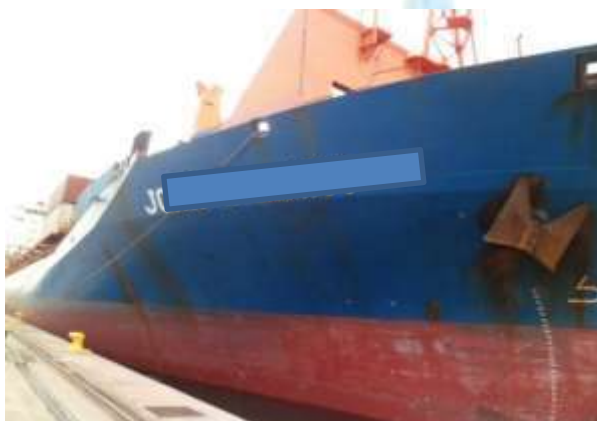
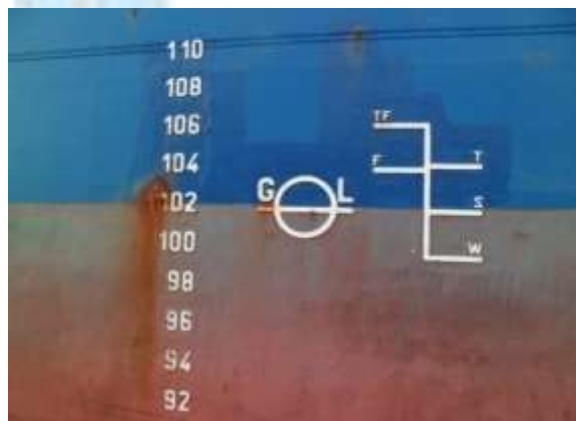
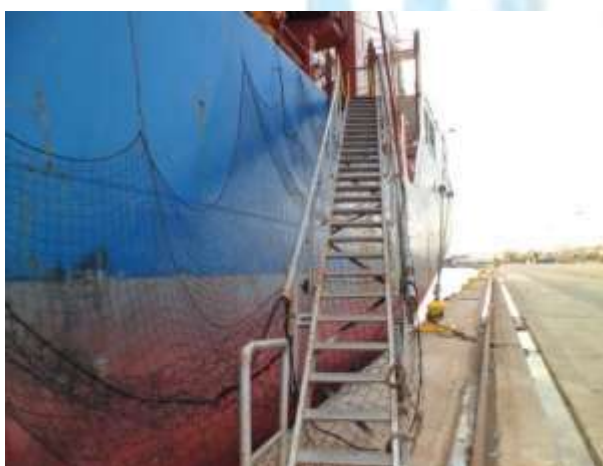
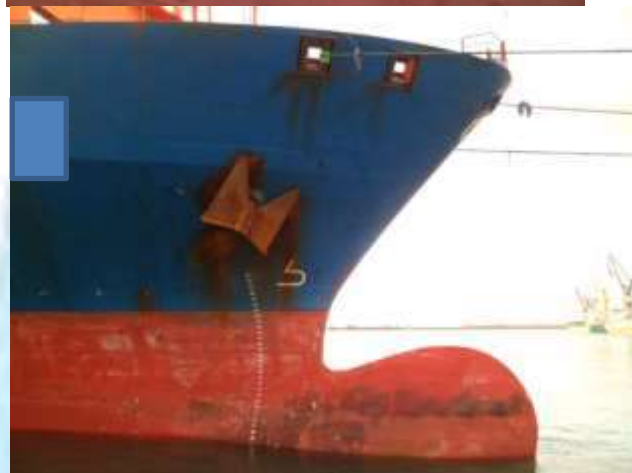
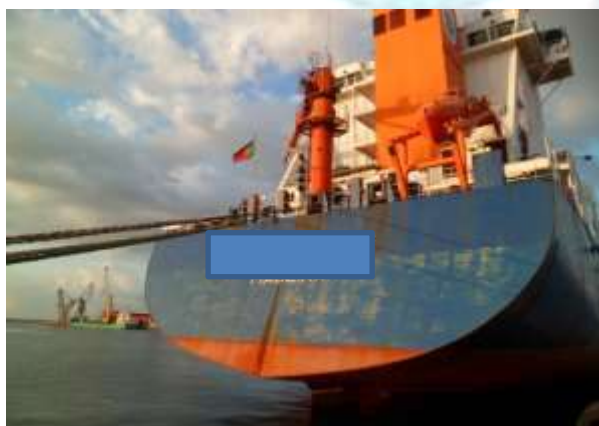
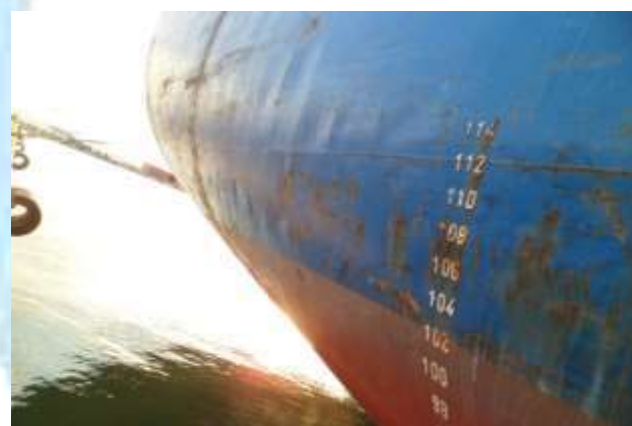
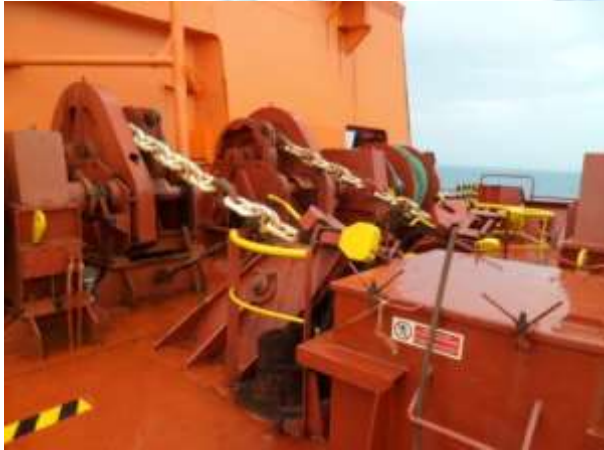
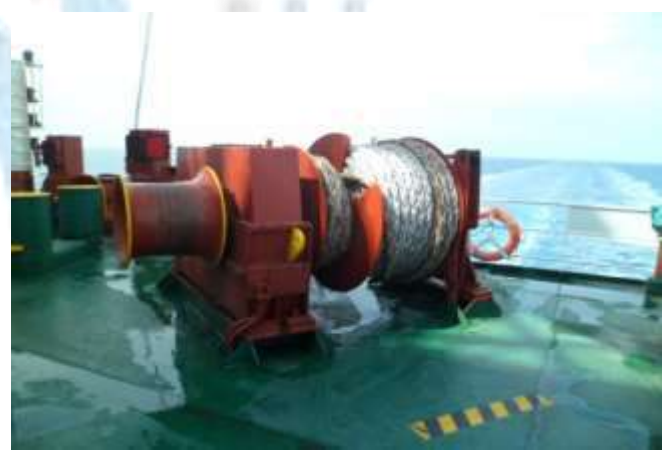
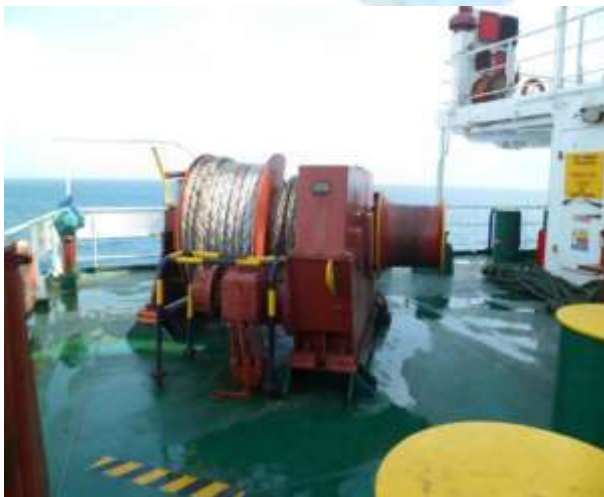
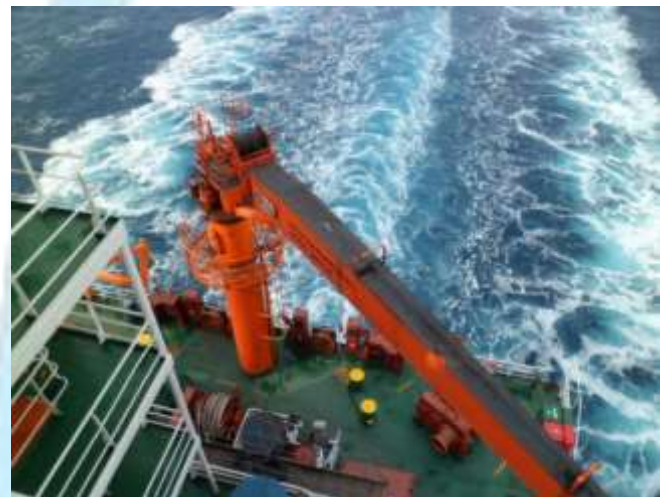
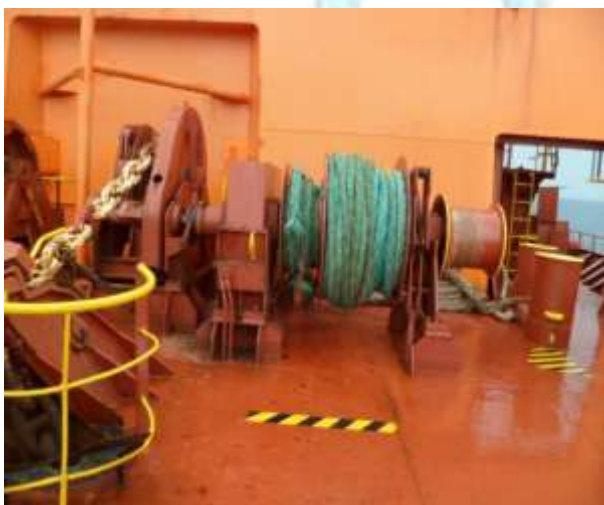
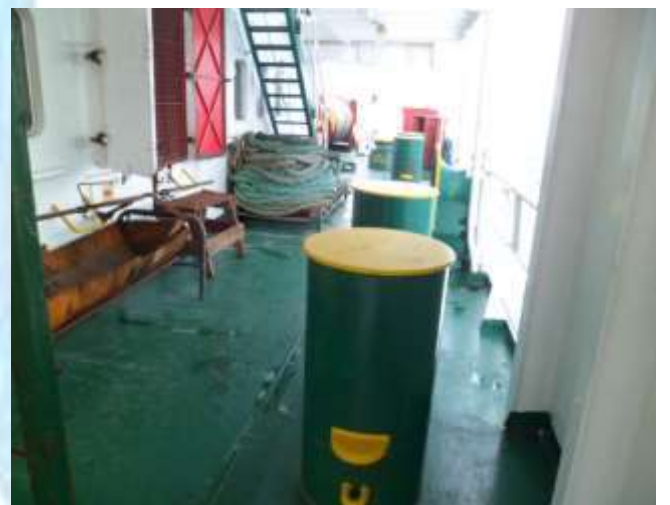
Hull External

Hull in generally found in good condition. Except for 'dent' as stated in our Report, Part-A.

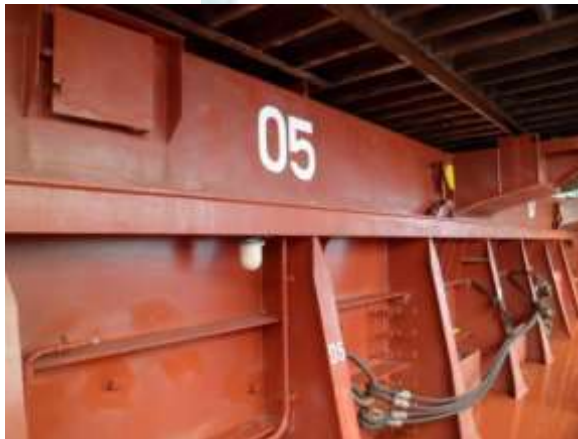
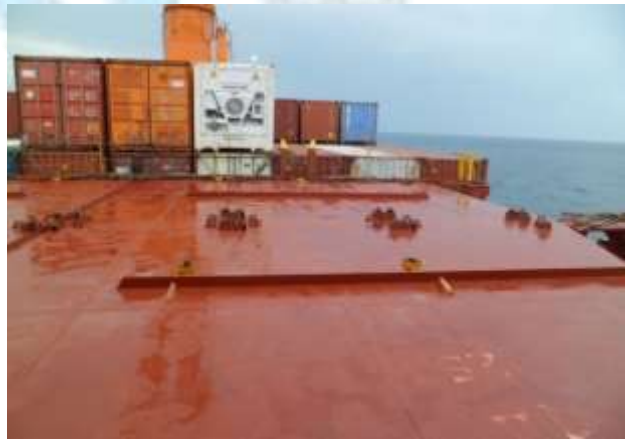
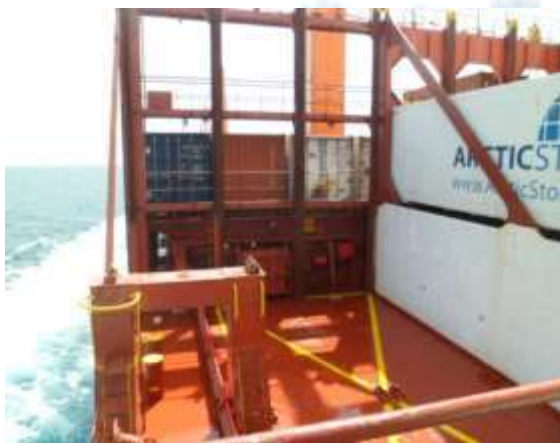
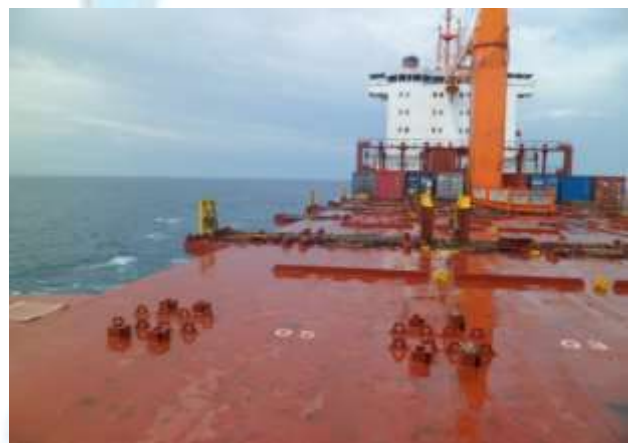
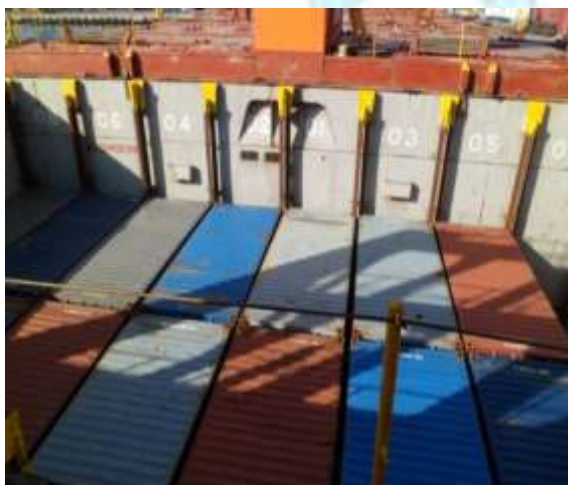
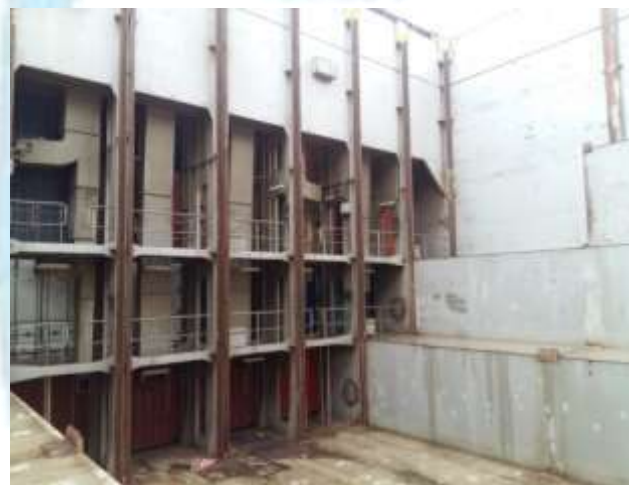
Main Deck

Coating of main deck found normal condition. No damage, dent or deformation found of the deck plating. Some fittings on deck such as vent head of FO tanks and Ballast tanks, gauge box, hydraulic valves box covers, piping line supports with minor rust.

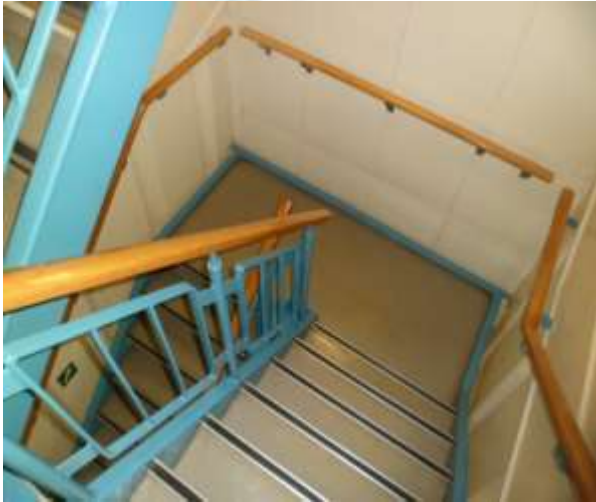
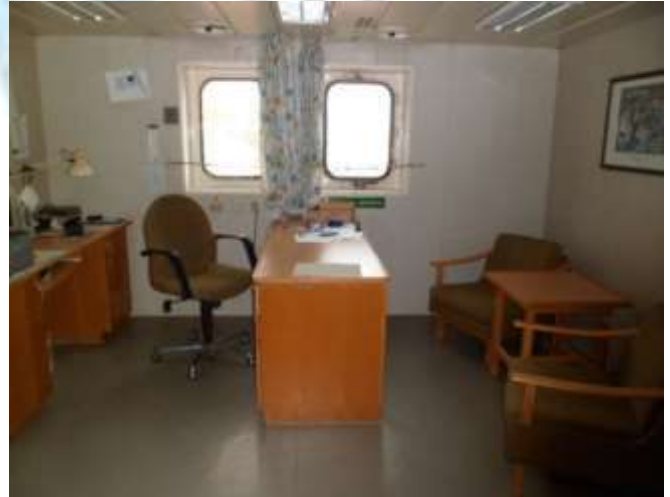
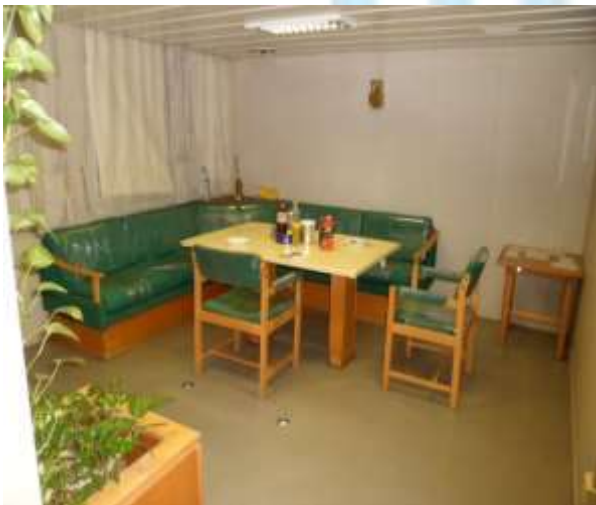
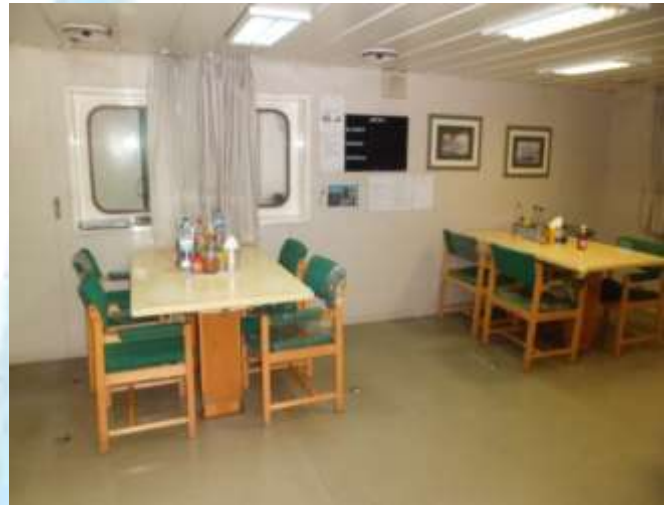
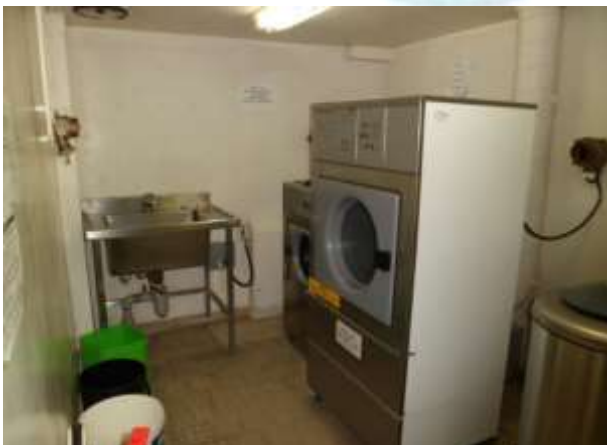
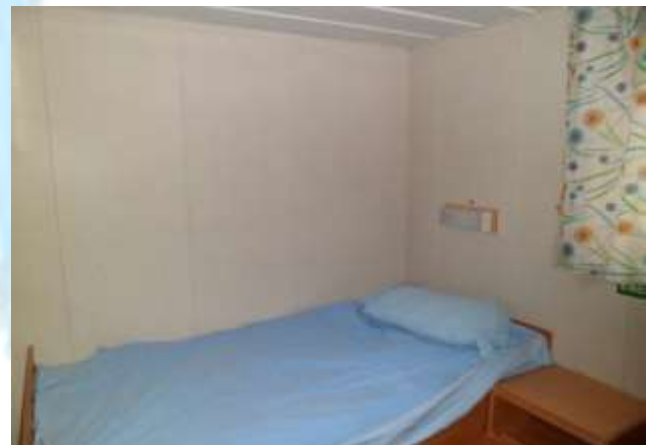
Surveyor's Comments about condition of Accommodation
All cabins are well furniture and maintained in high standard.

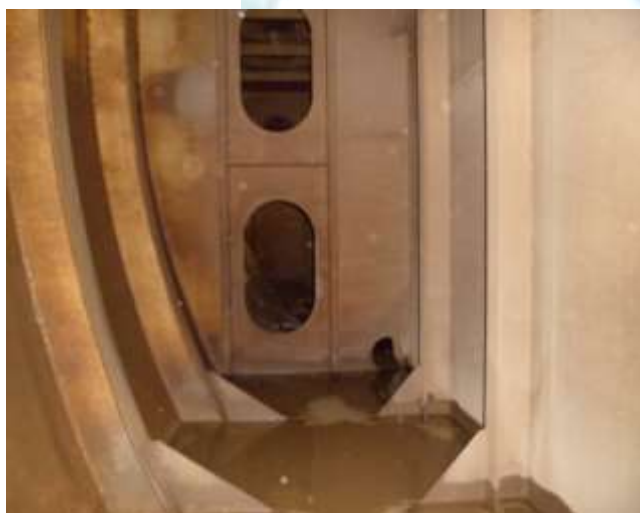
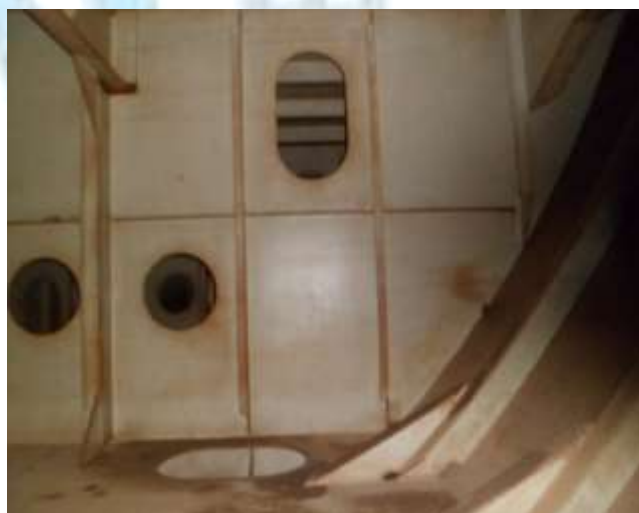
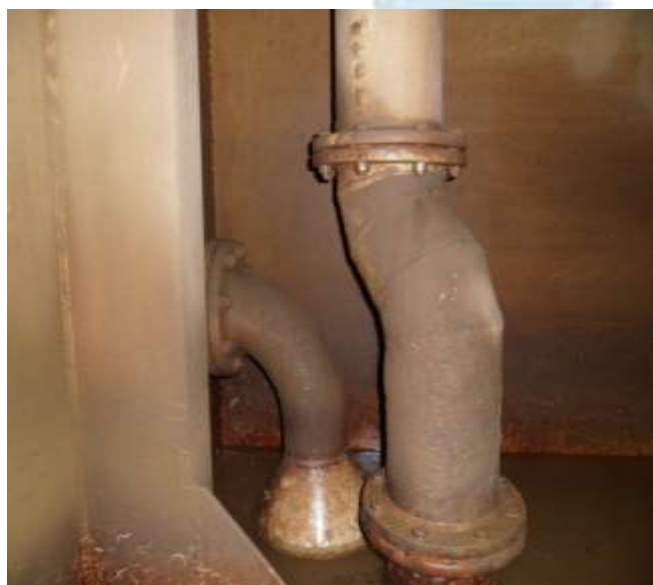
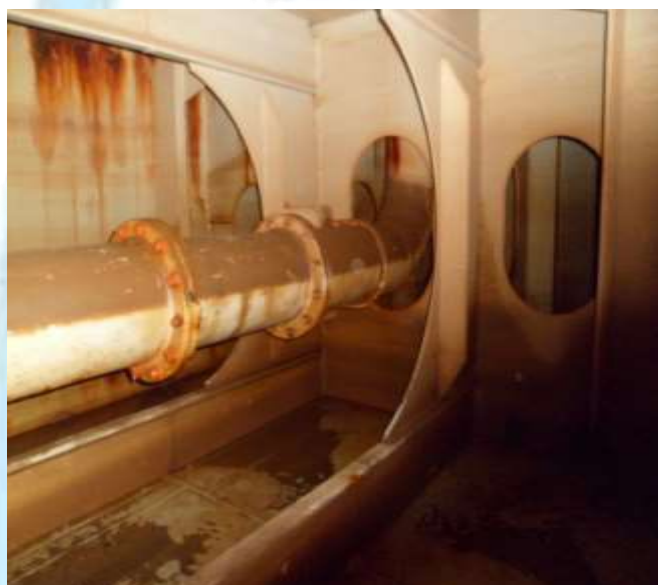
Ballast Tanks

Nos.1B2 side tanks (P&S), No.4B side tank Stbd, fore peak and aft peak tanks, voids no. 2 (P&S), upper side voids nos. 6 and 7 (P&S). The condition of all tanks was found satisfactory with excellent paint coating. Internal structure examined and found structurally sound with no damages, cracks or dents noted though the inspection except:
Fore peak upper bay paint found fair. Ladder in fore peak and no.2 starboard side tank upper section found with rust.
