PRE-PURCHASE ASSESSMENT
PRELIMINARY REPORT
MT SINOTECH MARINE
(OIL / CHEMICAL)

IMO NO.	8888888888
Port of Registry	BERGEN
Year of Built	MARCH 2013
Builder Yard	STX OFFSHORE & SHIPBUILDING/KOREA
Classification	DNV – GL
Vessel State	LOADING CARGO
Date of Inspection	15/02/2020
Port of Inspection	MONGSTAD / NORWAY
Inspection Company	SINOTECH MARINE
Inspection Type	PREPURCHASE INSPECTION
Client	CONFIDENCIAL

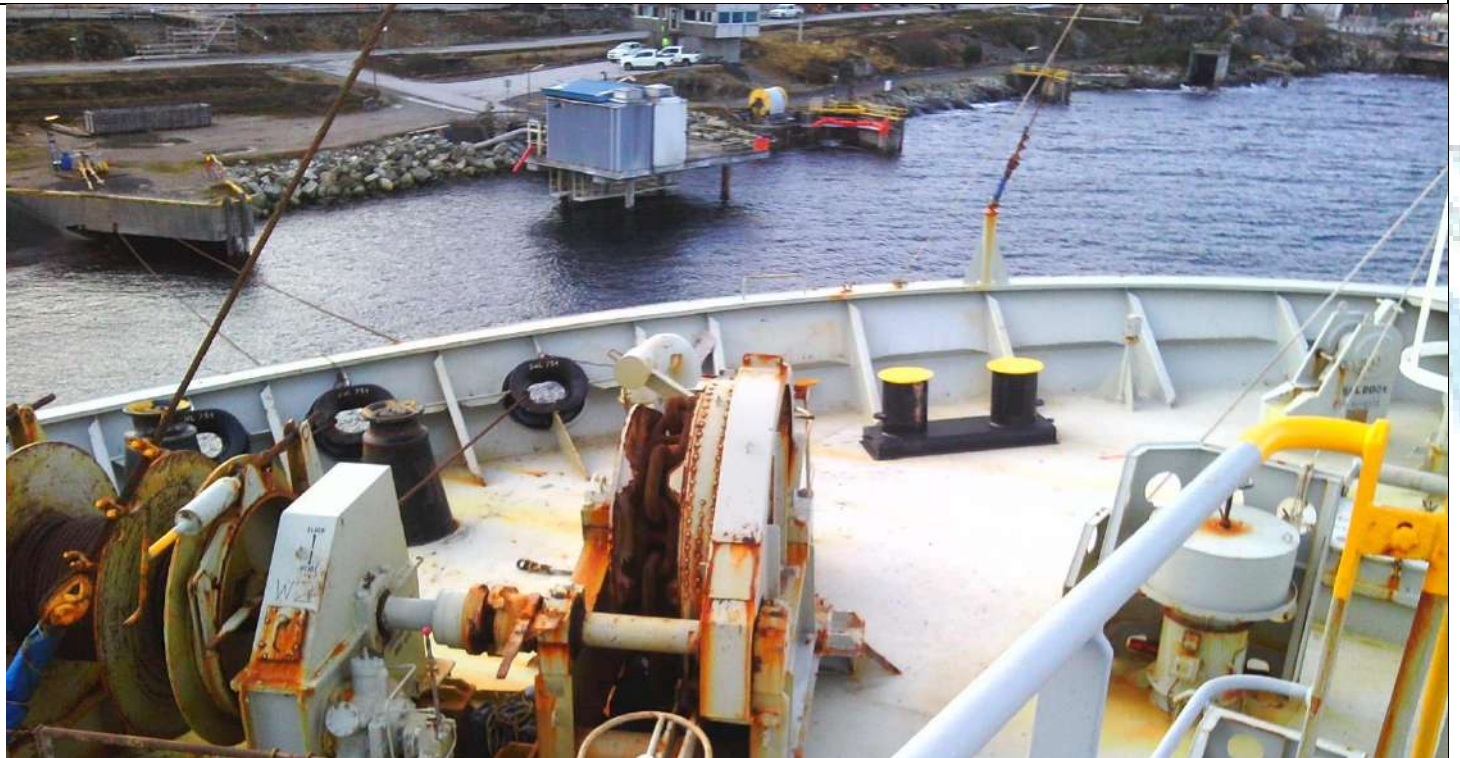
FORECASTLE DECK

THE FORECASTLE AND POOP DECK COATING REQUIRES MAINTENANCE, LOOSE RUST FOUND ON DECK AND THE LAST PAINT FOR DECK FOUND IN UNSATISFACTORY CONDITION

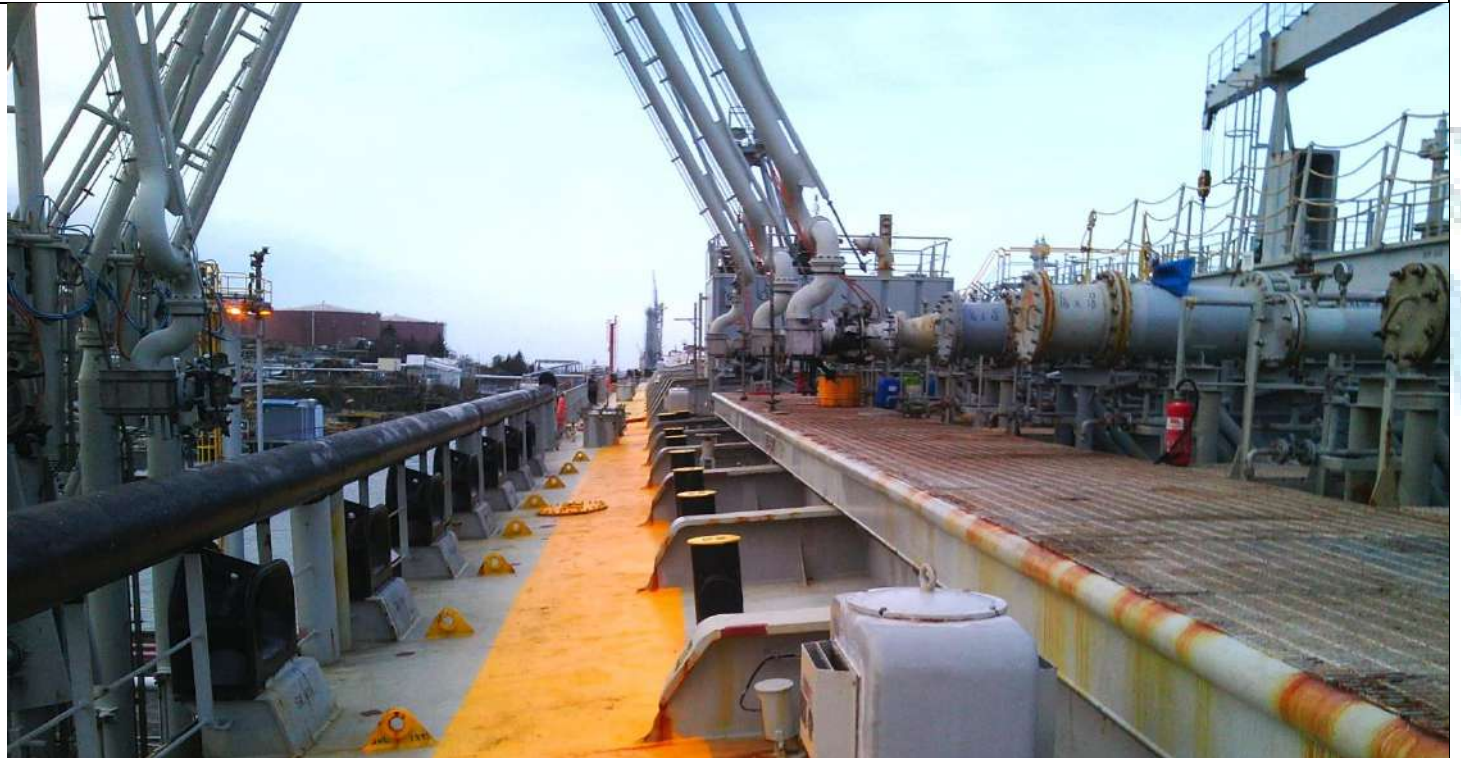
MAIN DECK PORT

THERE ARE SIGNIFICANT MARKS FOR FENDERS AND HULL HAVE LOOSE RUST ON PORT AFT SIDE. MAIN DECK, QUALITY OF LAST PAINT IS VERY POOR AND IN MIDSHIP THERE ARE PITTING AND CORRODED SPACES

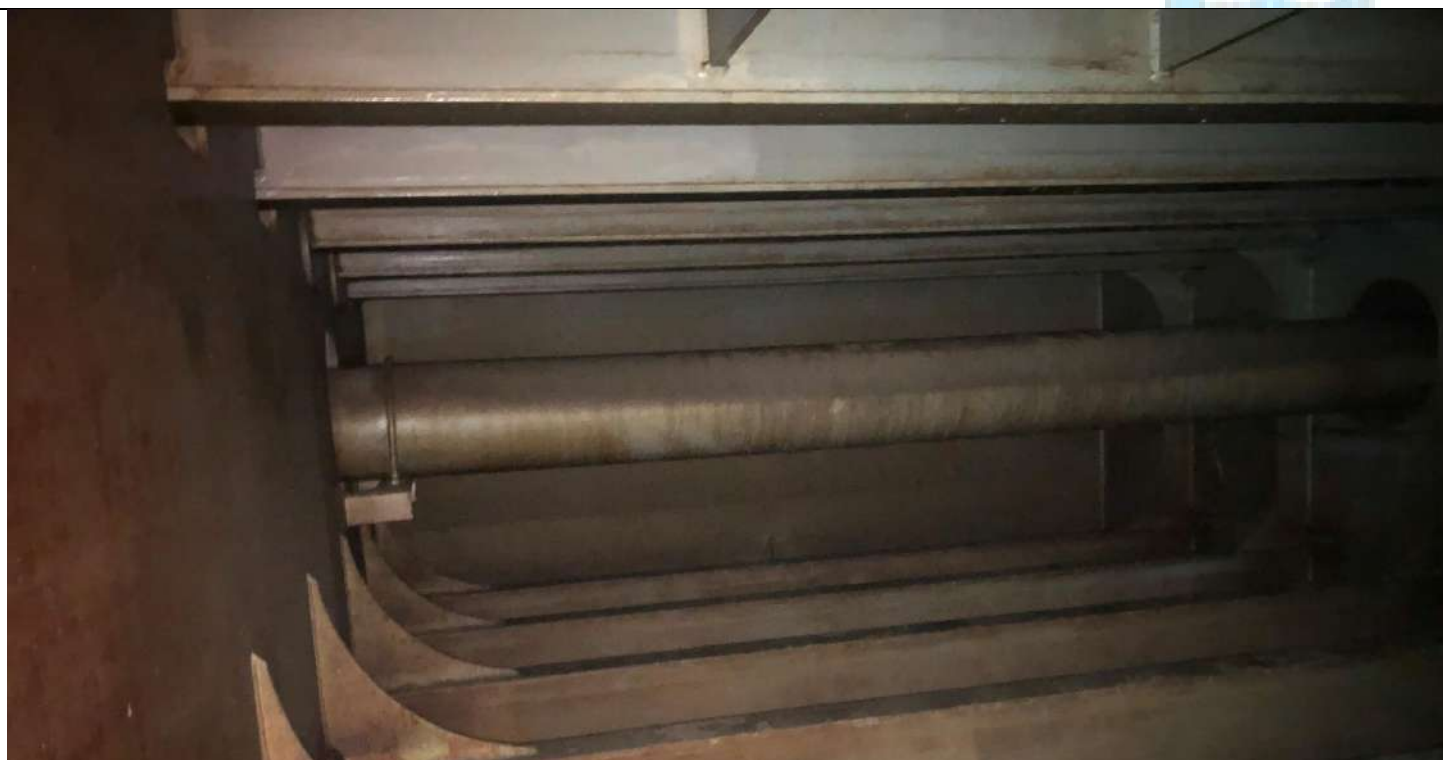
BALLAST TANK INTERNAL

SURVEYOR INSPECTED no. 1p and no. 3s ballast tanks. overall condition is good, and all anodes are intact. cargo tanks were not inspected, however, there are in good condition as per ship records.

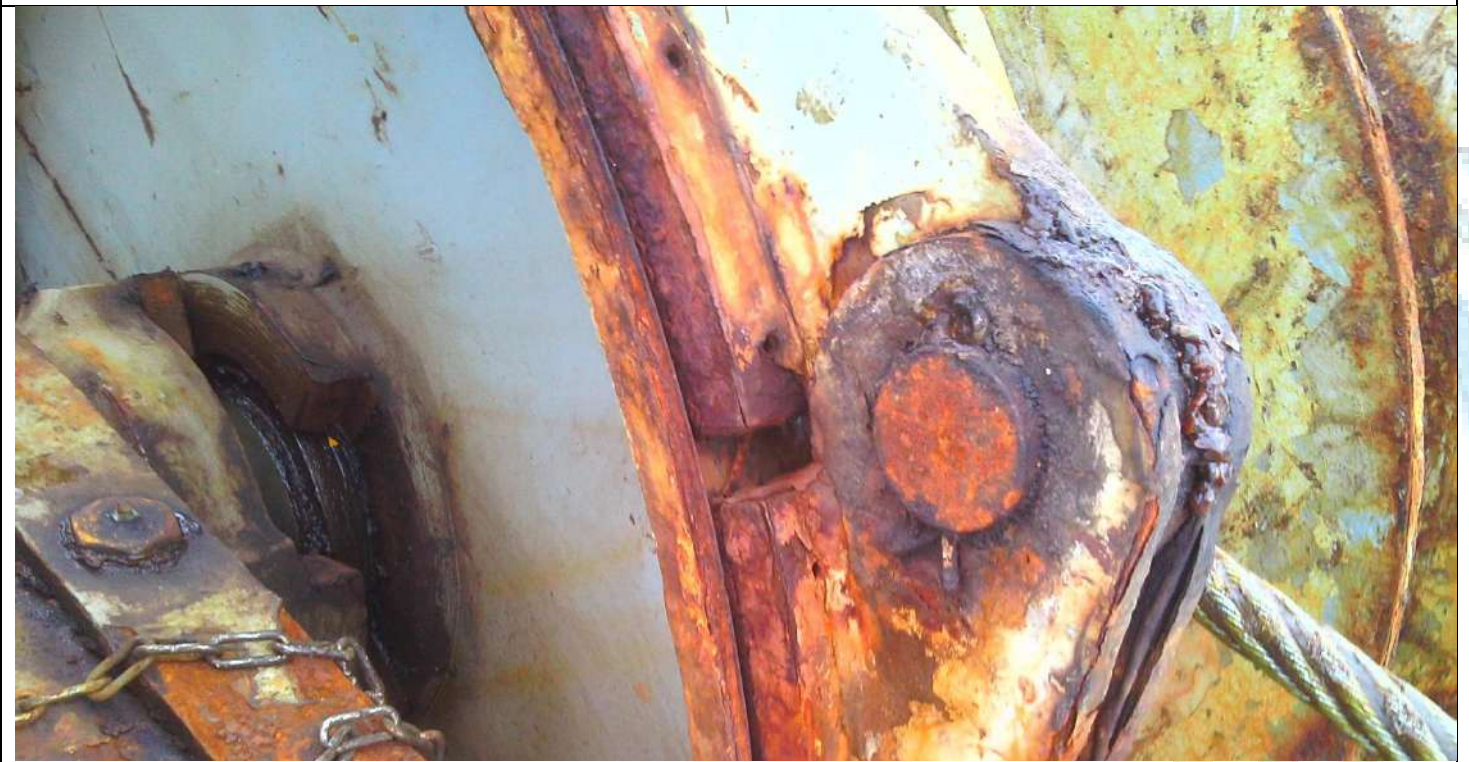
11	Steering Gear	Good	Steering gear oil pumps and limit switches are noted in good order
12	Hot well, Condensers	Good	No corrosion noted
13	Hydraulic Power Packs	Good	No sign of excessive leakage
14	Windlass & Mooring Winches	Fair	Equipment have loose rust and brake liners, brake pads need a maintenance, some lubrication points are painted
15	Deck Cranes	Good	
16	Cargo Pumps	Good	FRAMO system cargo tanks are in good visual condition
17	IGS	Good	Logs have been checked, no unexpected stop drying operation
18	Ballast Pumps	Good	FRAMO system ballast pumps
19	Cargo Heating	Good	Heaters are just for tank cleaning. 2 Slop tanks have stainless steel heating coils
20	Tank Cleaning	Good	
21	Fixed Gas Detector	Good	In working order

ANY MAJOR DEFECT – WINCH CORROSION

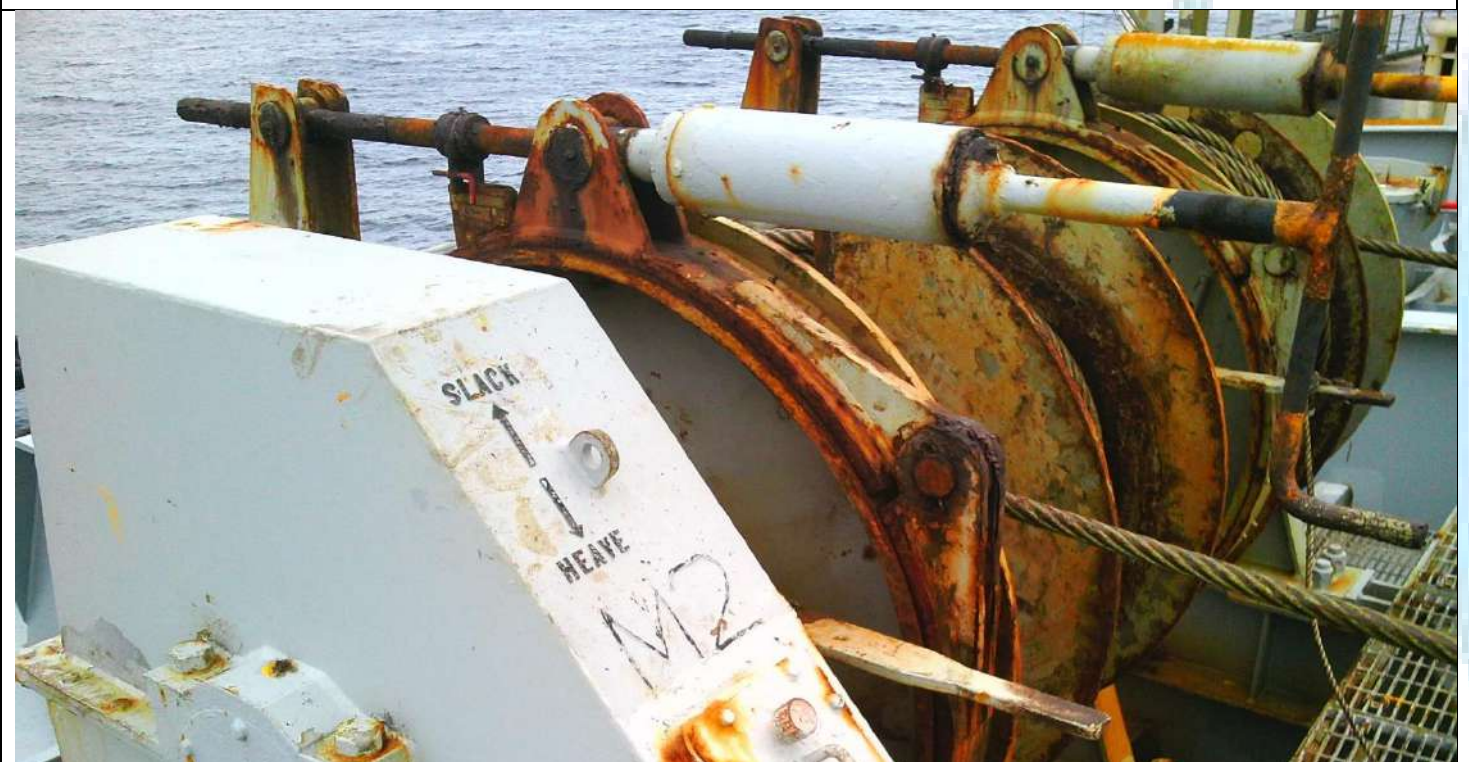
ANY MAJOR DEFECT – WINCH CORROSION
