# MV GAS XXXXXXXXXX

## PRE-PURCHASE CONDITION ASSESSMENT

### PART A: SUMMARY REPORT

LPG CARRIER (IMO 99999999)

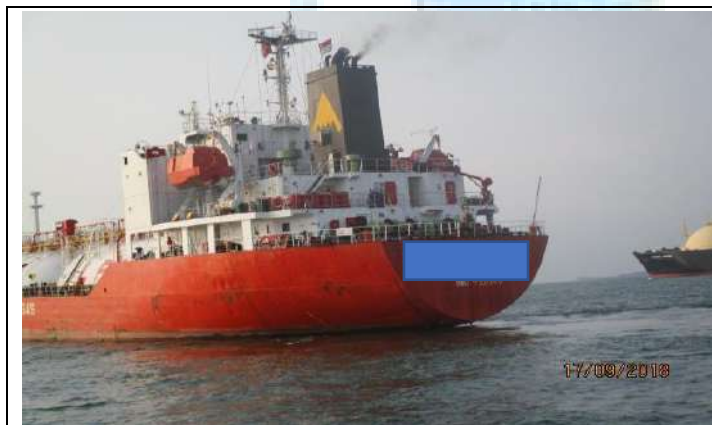
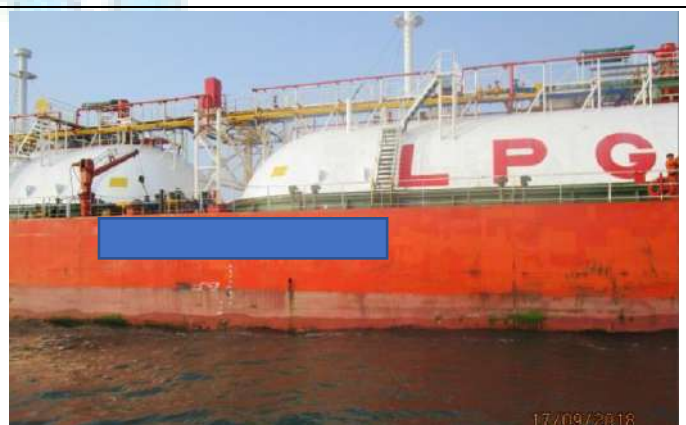
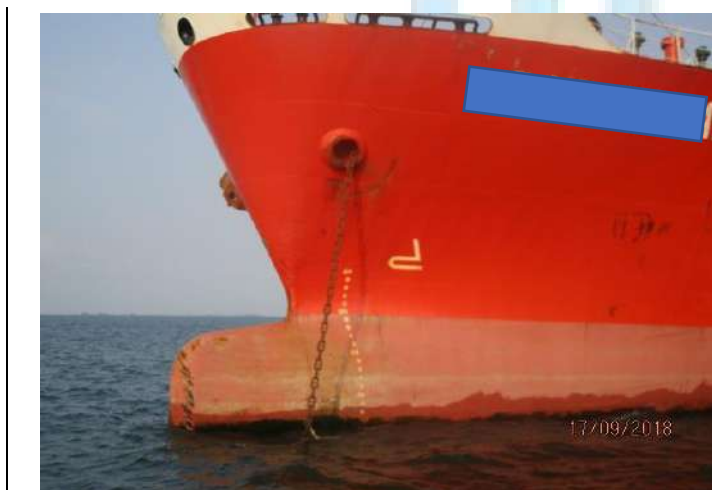
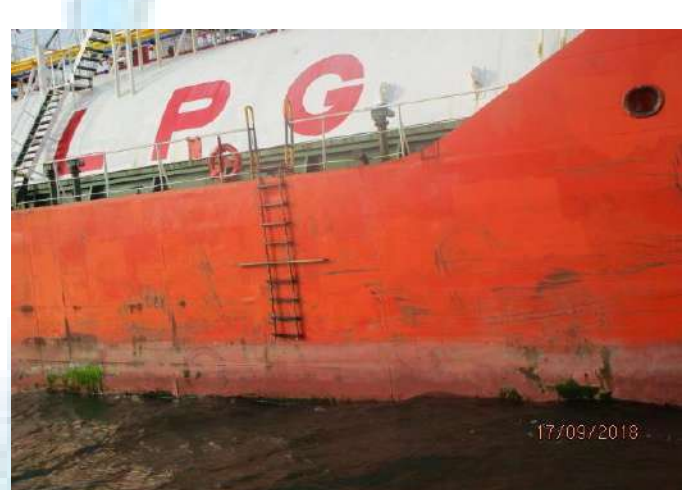
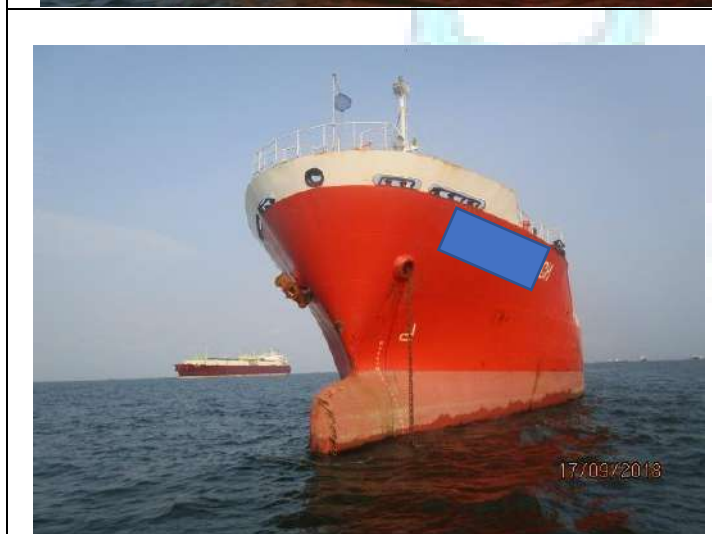
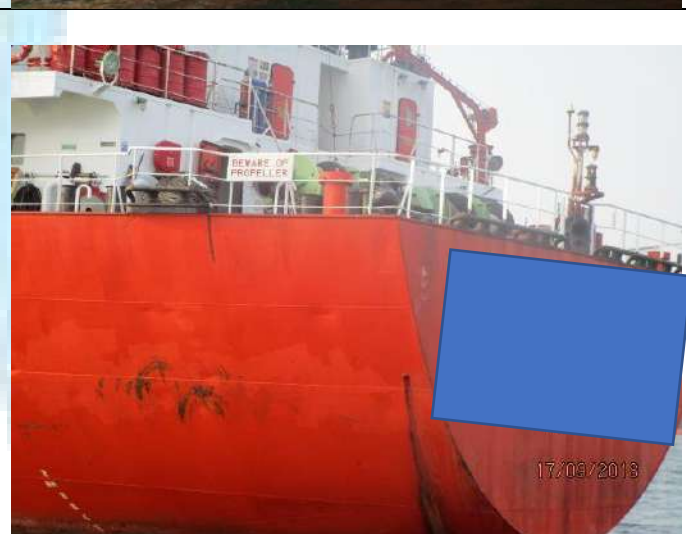
#### 1. Hull Structure

Rib caging was noted on the aft portion both sides in between transverses. Fender marks were visible on either side. Draft and load line marks found fair. There was no visible damage, dent, crack, or any kind of deformation on the visible part of the external hull except as described above. Hull fouling was noted below 4 m draft and one could expect speed improvement after cleaning. Scattered rust patches along the weld seams noted on Topside & vertical portion.

Starboard anchor was stowed in place correctly and port anchor was down. Fender black patches were noted below the name in the bow. Also, similar fender black patches noted in the aft quarter port & starboard side. We could not see the Rudder and propeller as was under water.

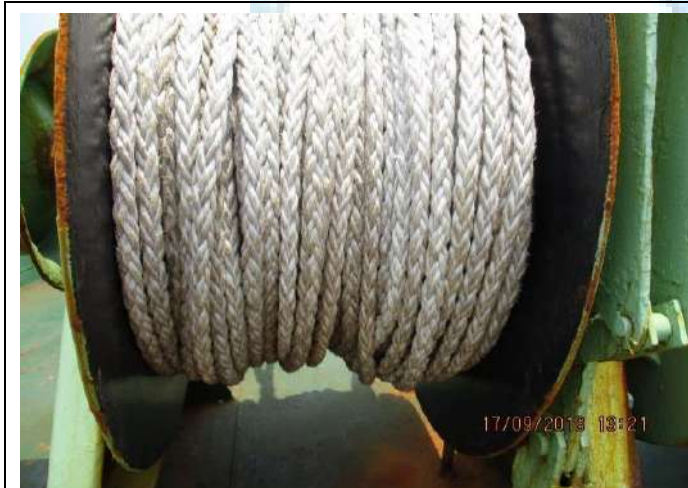
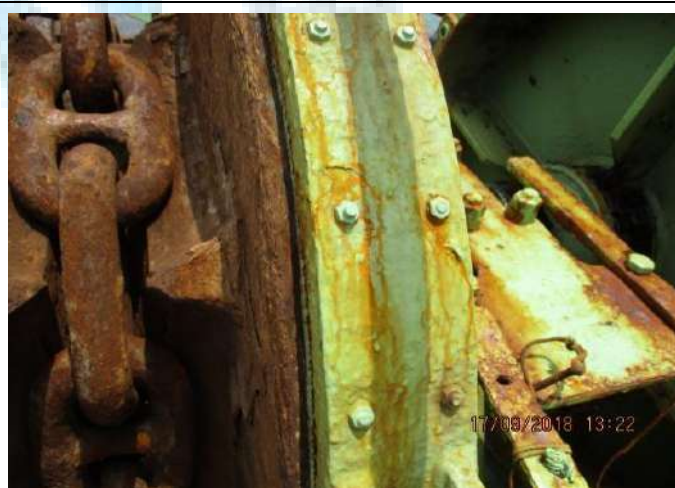
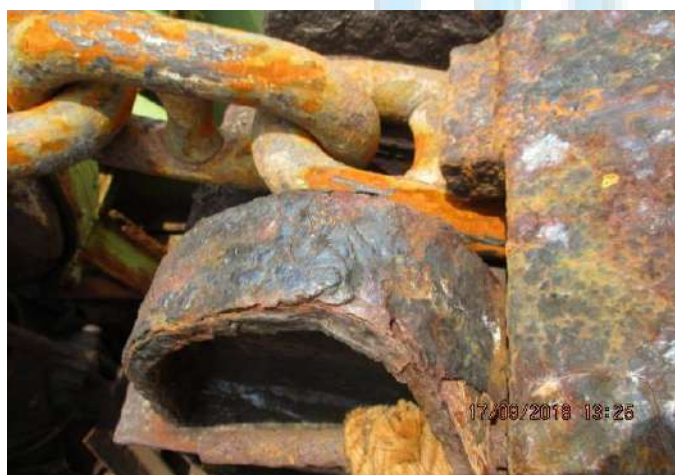
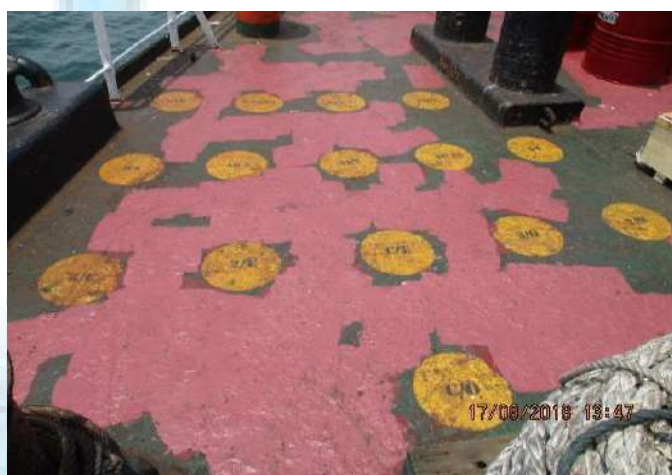
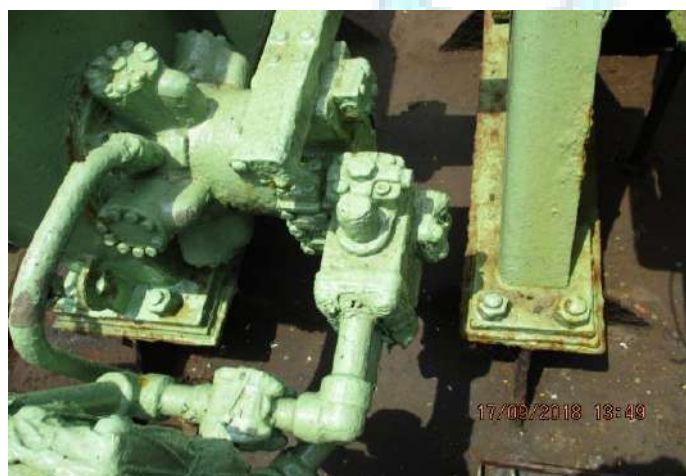
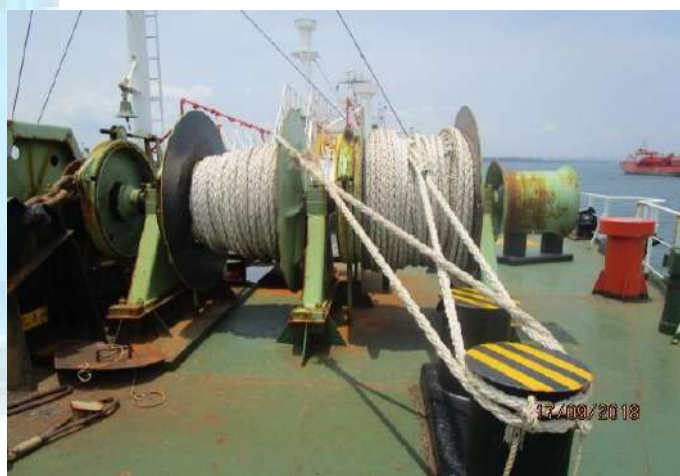
### 2. Forecastle and poop Deck

Condition of mooring equipment, windlass, winches machineries, appeared in order and reported working well. Brake drum edges for the winches were noted with thick rust. Some of the exposed brake drum portions noted rusted. We did notice some snap back zone marking. We did not notice any Hydraulic leak. Rust stains were noted around anchor chain and windlass on the Forecastle deck.

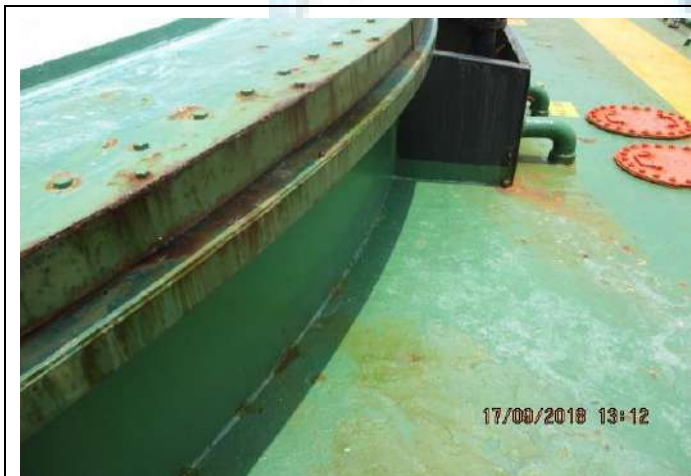
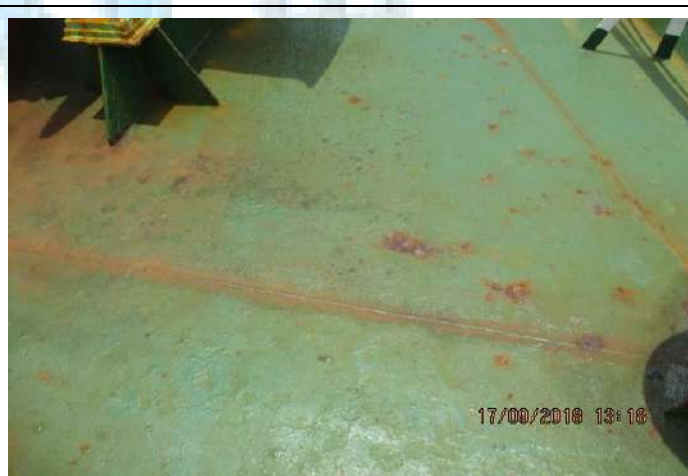
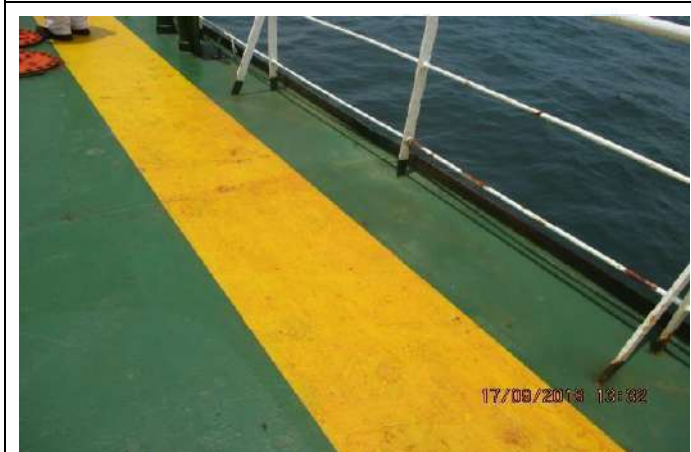
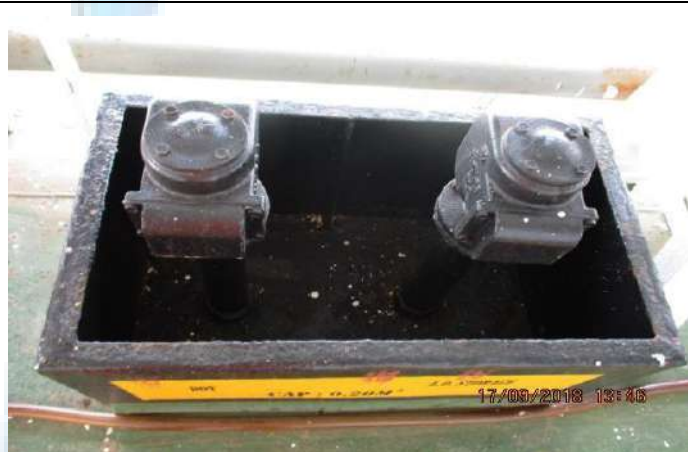
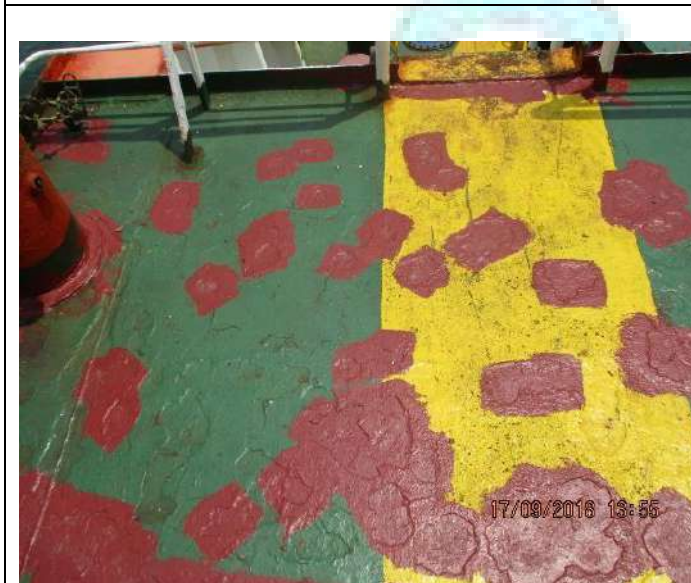
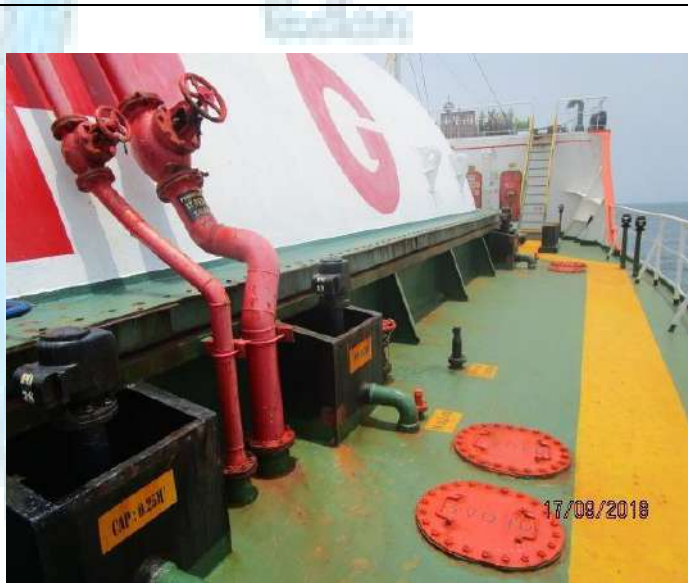
### 3. Main Deck & Deck Machineries

Main deck coating in general looked fair with widespread rust spots. Coating over pitting scabs noted all over main deck though none of them were very deep. Railing appeared well painted. Condition of the watertight doors , forepeak stores appeared fair.

Hydraulic piping found free of leaks. Roller fairleads & Fairlead bases noted to have rust patches. Condition of Bunker Manifold, one on each side found fair. - Condition of lifeboat davits and cranes found fair. Vessel does not have Port Accommodation ladder.

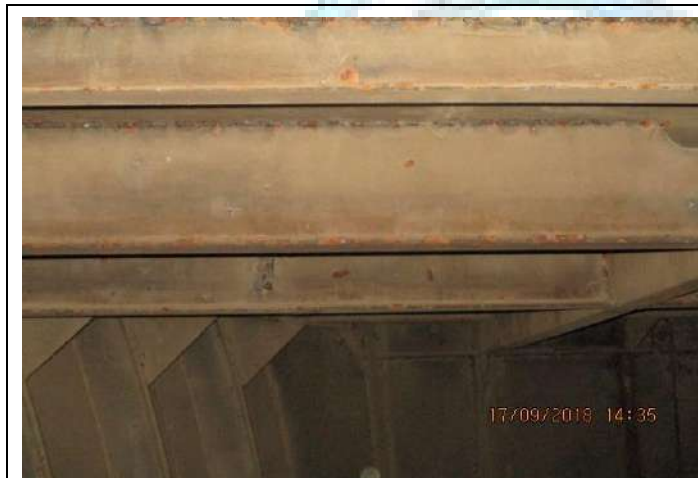
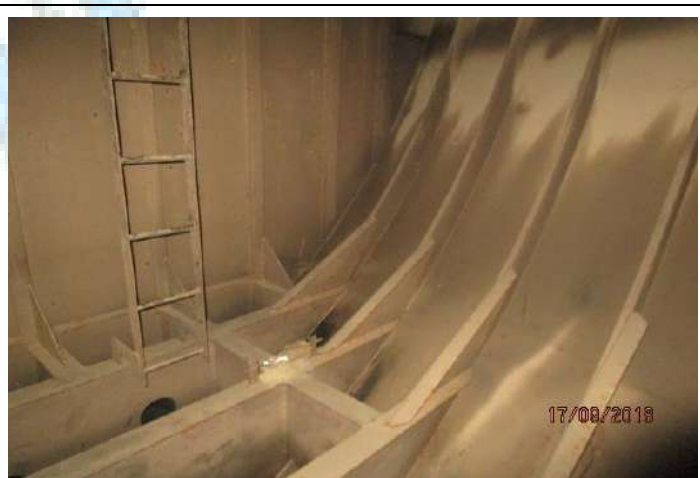
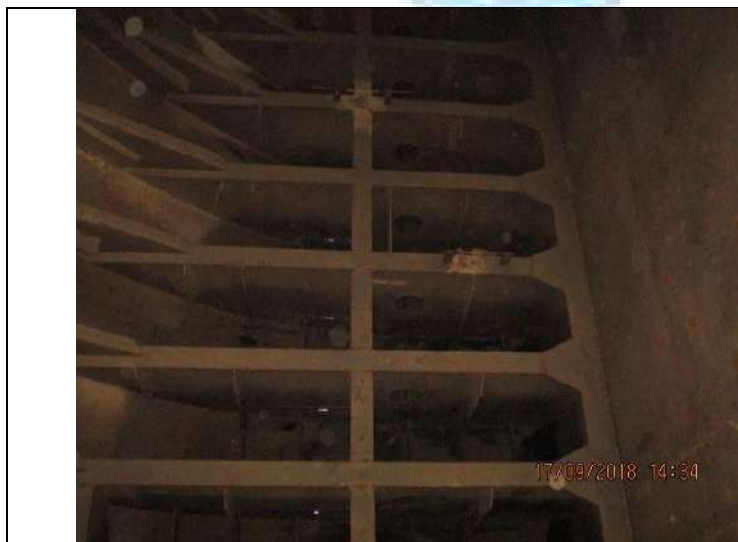
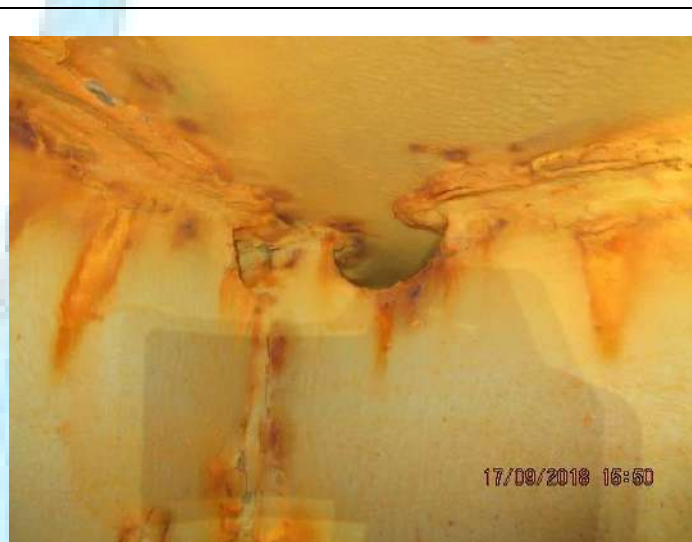
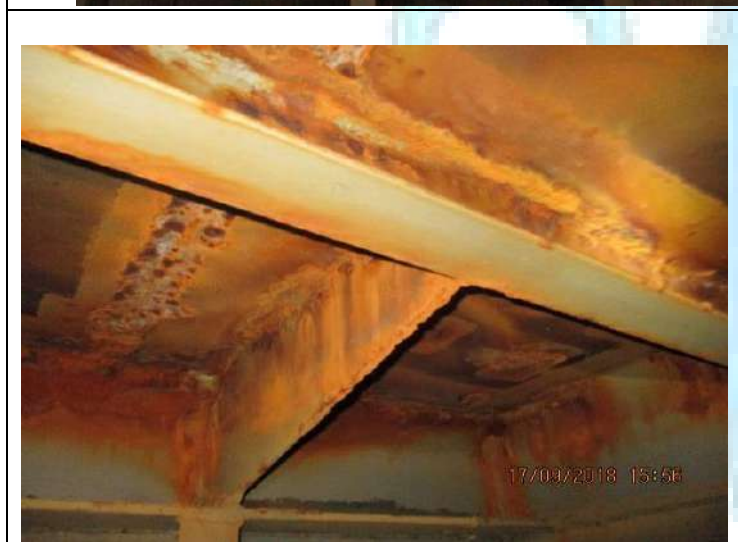
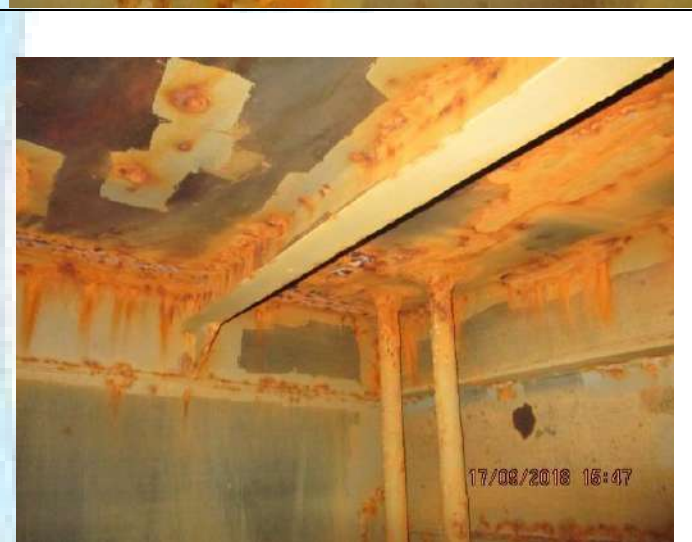
## 4.0 Ballast Tanks and Void Spaces

No1 Hold space: Bottom portion found to widespread sport rust. Some steam line insulations found adrift. Saddle wooden chokes for the tank support appeared in order. Paint work on tank noted rusted. No2 Hold space: Bottom portion found to widespread

sport rust. Saddle wooden chokes for the tank support appeared in order. Paint work on tank top is noted rusted extensively.

No2 Void space: Bottom part extensively rusted. All other parts in good condition. We could see the coal tar epoxy intact in many areas touched up with Grey epoxy. No1 Port tank: Anodes consumed about 50%.Spot rust on the stringers, handrails, rail supports noted. .Edge rust noted on ladders, transverses & longitudinal. Tank in fair condition.

Aft peak tank: Severe rusting noted in underdecks. On the whole rusting noted for about 25 %. Both Port & STBD aft peak tank would require maintenance as priority.

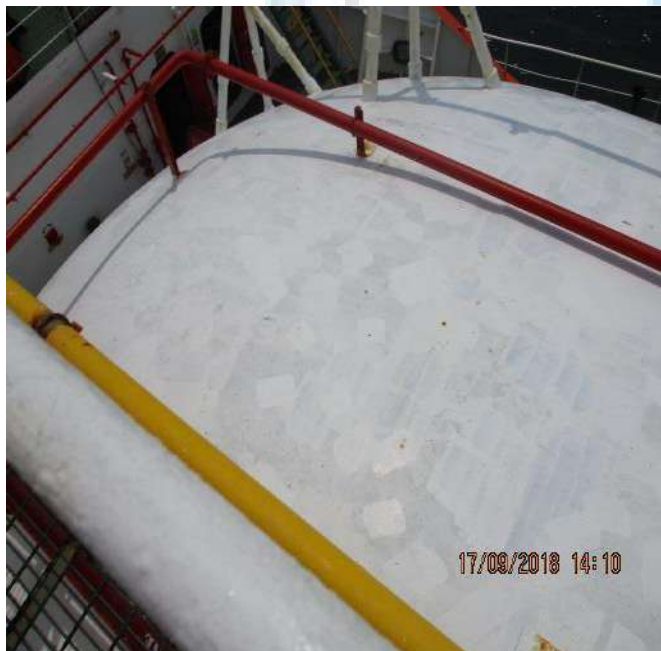
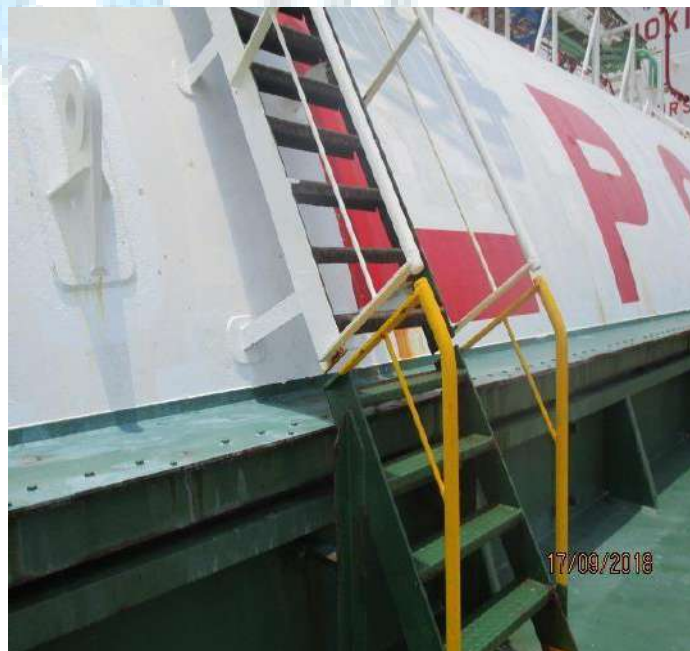
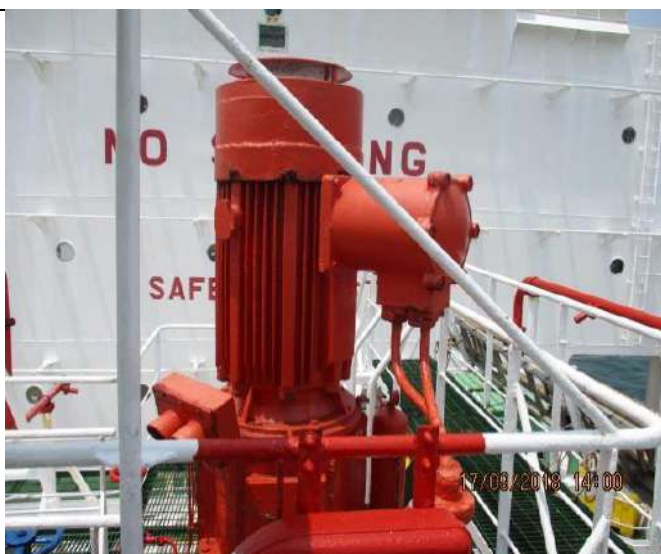
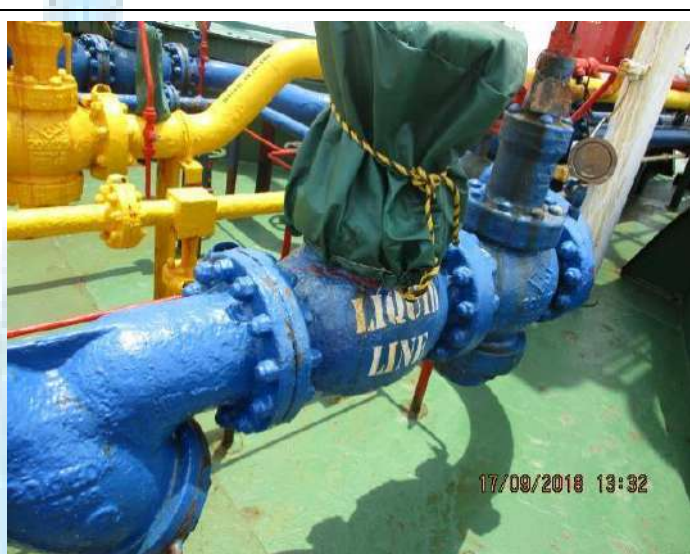
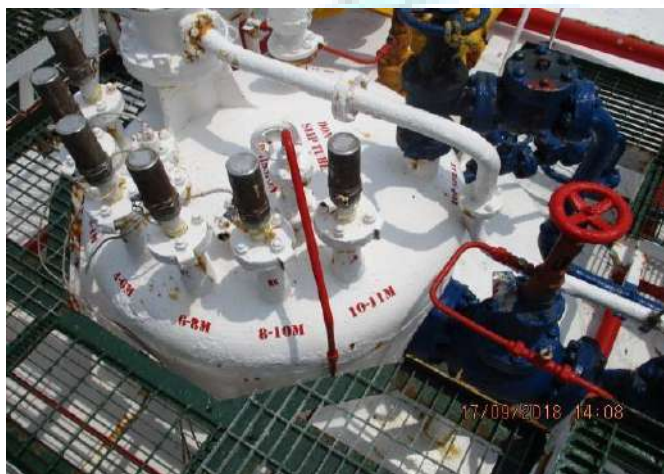
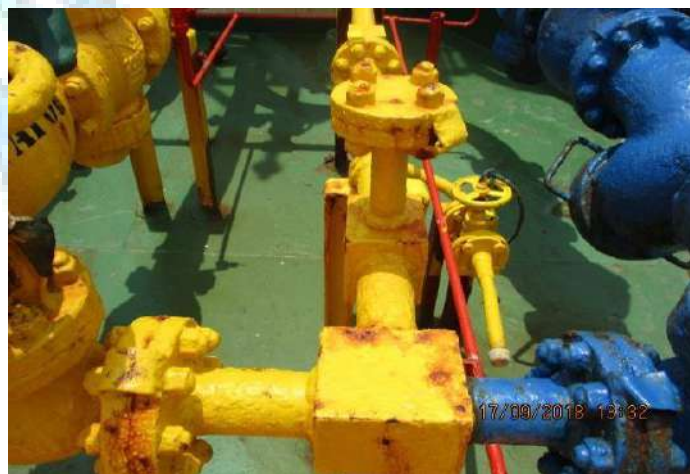
## 5.0 Cargo Pumps, Compressor Room, CCR, Cargo Tanks & Domes

Vessel has been carrying Butane past one year. Master was not willing to share any pictures or repots as per the instruction the Mangers. There was no cargo operation during our inspection. Vessel is not fitted with any IG system. Condition of the cargo piping and fittings, relief valves, valves, flanges, support brackets, clamps, nuts and bolts appeared fair. Manifold piping, attachments and valves found to have spot rust.

There are two Deep well 4 stage Electric Shinko made cargo pumps, one for each tank near the aft end. Capacity of each pump is 300 cum/hr. (sg 0.600) at 110 m water column and 250 cum/hr. (sg 0.946) at 120 m water column.

Cargo compressors were not running but appeared to be well maintained. No leakage observed from both bulkhead stuffing box and compressor shaft seal. Compressor room and motor room were maintained in clean condition.

Due to limited access to running record and maintenance as ship's Master did not allow, more technical details are not available. All local gauging instruments were apparently found in normal condition. All the Controls are essentially local.

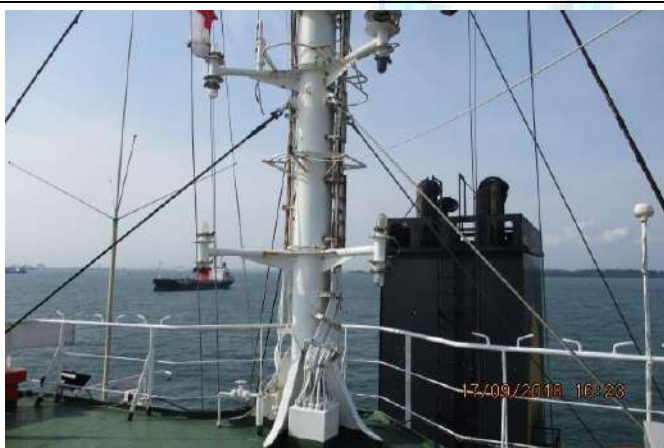
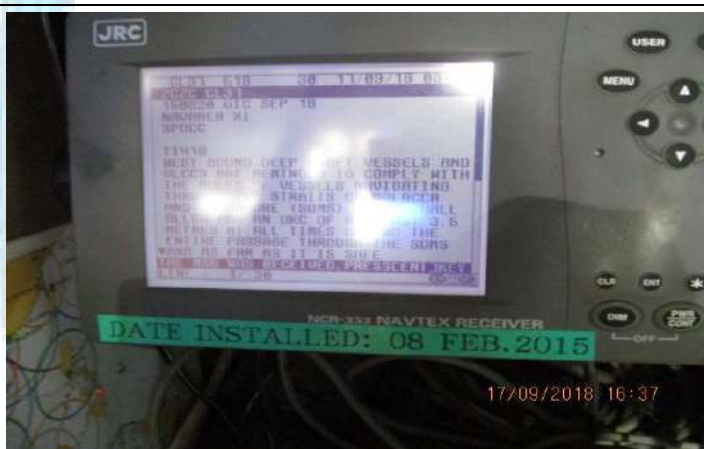
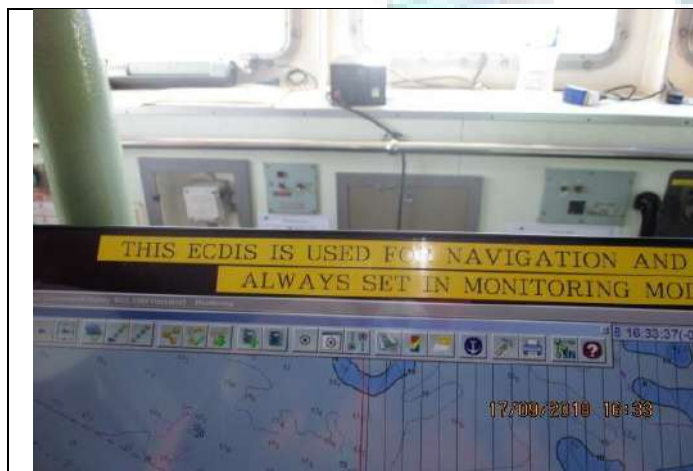
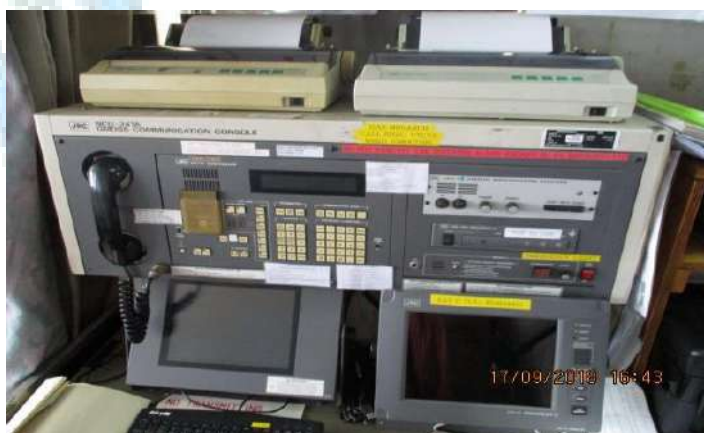
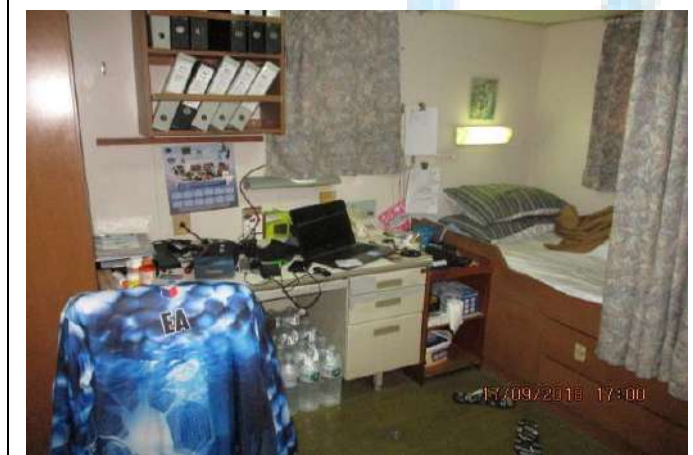
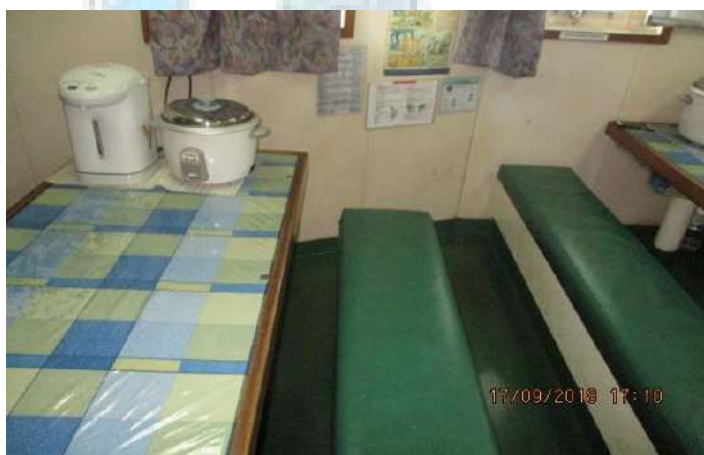
### 6.0 Navigation Bridge and Accommodation

The vessel has Japanese type accommodation. Only the Master and Chief engineer have attached bath & toilet. All others have common bath and toilet facilities. We have seen drums and buckets with water filled in laundry & bath areas and foul odor which indicates water rationing on-board. On top of that, the water consumption was indicated as 1 t/day. When we commented that that is too low, then they reverted as 1 to 2 t/day. Chief engineer reported Fresh water production as 5 t/day and we remember seeing in the log much lesser production (1t/day) Chief office advised that the vessel took fresh water 100 tons just two days prior to our inspection. The air condition system is not effective, and the owners may land up investing on the compressor & Evaporator.

It was reported that all the Navigation and communication equipment's are fully operation. We had suspicion in one of the Radars operations as this unit has two serial numbers. Later, we saw a new unit supplied to the vessel. Hence, whatever is reported by the officers cannot be taken as true. ECDIS units are made by Maris 900. We have seen both units operational. However, the second officer could not demonstrate the way points during Singapore approach in ECDIS. In general, for this age of the vessel, the Navigation equipment maintenance cost runs very high unless replaced.

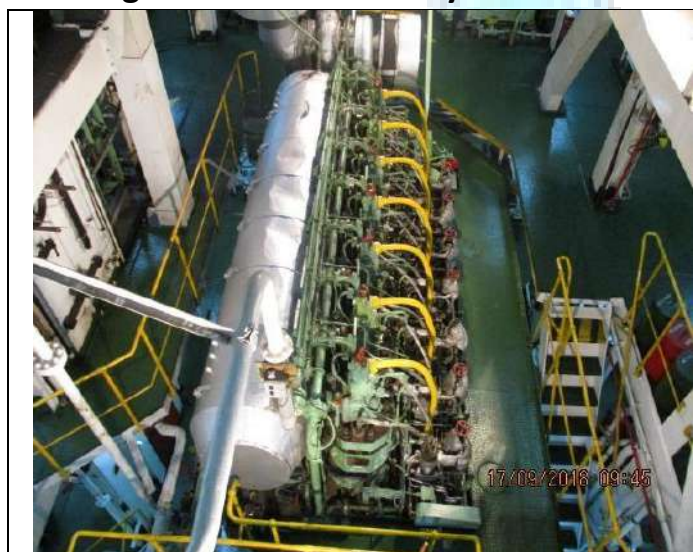
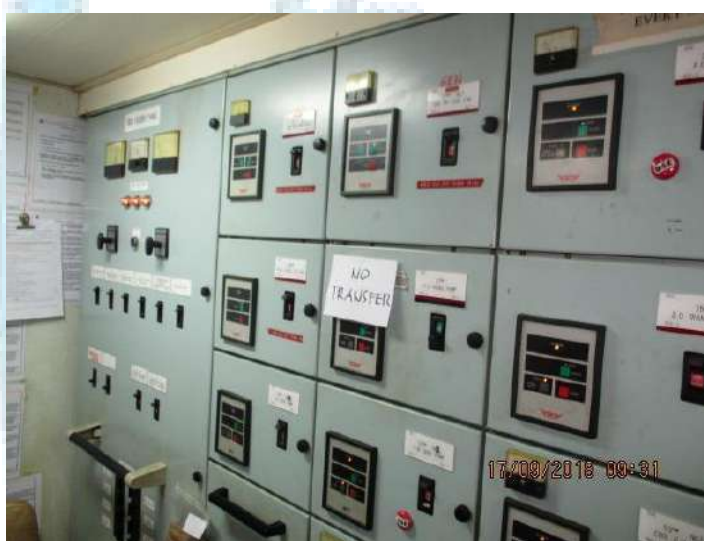
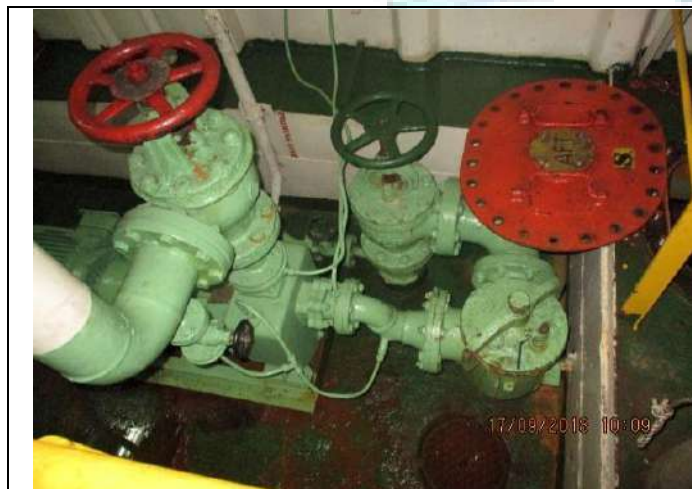
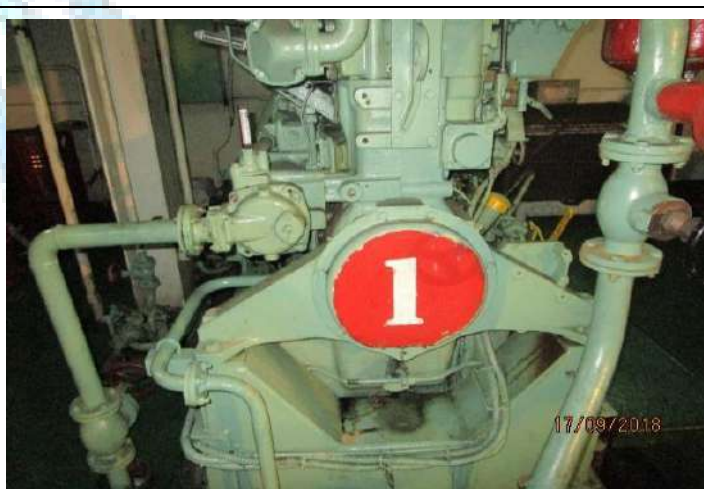
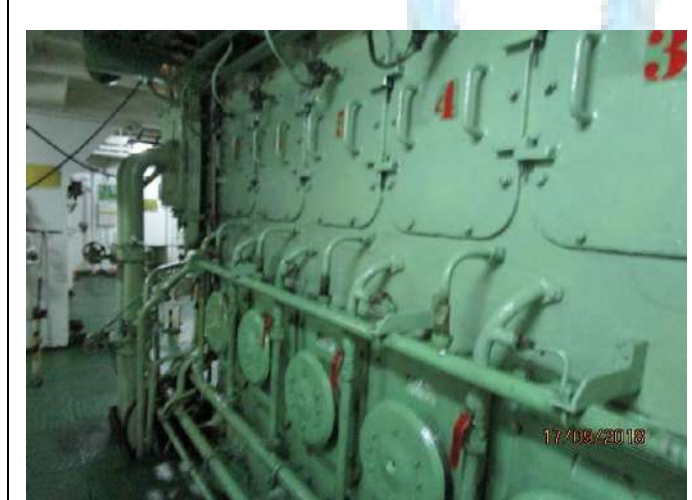
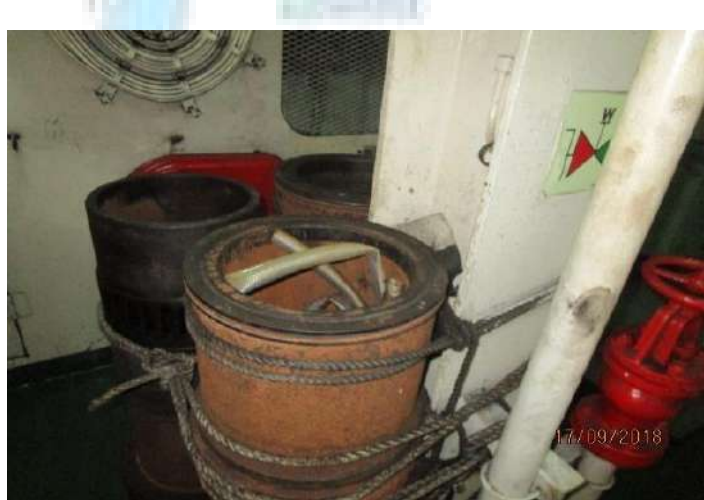
### 7.0 Engine Room Machinery

Engine room is small and maintained in fair status and the engine externally appeared to be satisfactory with no significant leakages of fuel or lube or cooling water. As per the records, all the units were decarbonized in the month of July to August 2018. We do not know the reason for such rapid overhauls. From the liner wear data, it appears as though no5 & no7 liners were renewed. But we had seen seven old spare liners in the Engine room. Buyers to take up this with sellers. Secondly, ME has some higher level of vibration in the intermediate shaft known from the Class survey report which could be one reason for not running Engine at Full RPM.

Is the Main engine capable of producing 12.86 knots for a consumption of 8.9 t/day as per the performance records? We have our doubts. The Main engine cannot perform as per declaration in form C for charterers. Auxiliary engine performances were recorded at 65% power. Exhaust temperatures were shown in the range of 190 to 205 Deg c. The exhaust temperatures are indeed so low. We did see some metal exposure close to auxiliary engine Turbochargers which is a fire hazard and SOLAS violation. Some water and Diesel noted below the Auxiliary engine close to the flywheel. Engine room tank top and bilges were found rusted. Most of the Sea water pumps are gland packed with leaks around, Pump foundations are thickly rusted and coated with paint.

Overall housekeeping in ER is in fair condition. We noted lot of soot on the motor suction grids. There is no Crankcase Mist detector for the Main Engine.

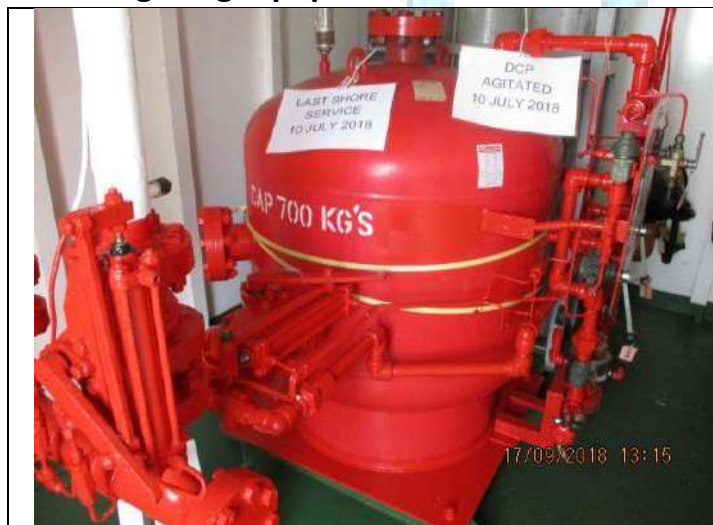
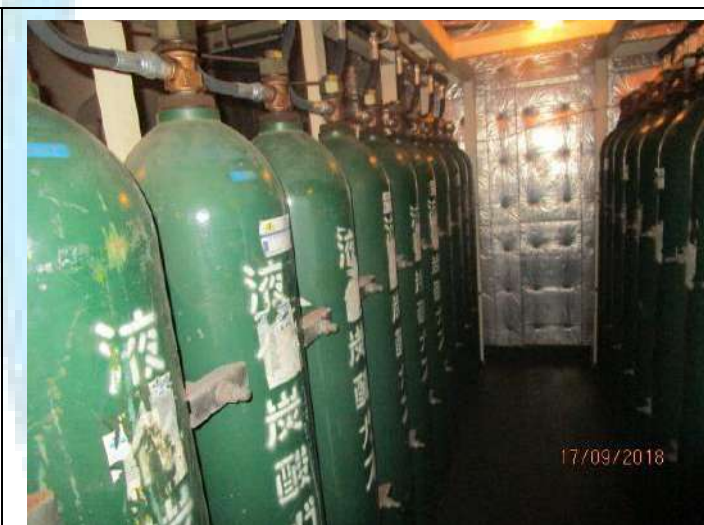
## 8. Firefighting Equipment

Vessel is provided with CO2 system made by Kawasaki for engine room and Compressor room fire protection. CO2 room is in Engine room. Vessel has dry powder protection system for the cargo area. Vessel has water spray nozzles to cover exposed area of cargo tanks & cargo manifold. Vessel is also arranged with Sprinkler system with small holes in pipes for each cargo tank. All of them appear to be in order.

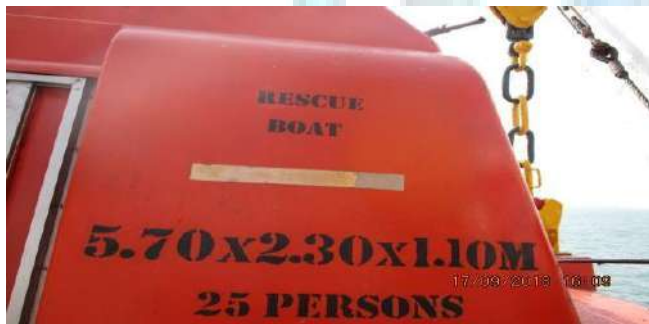
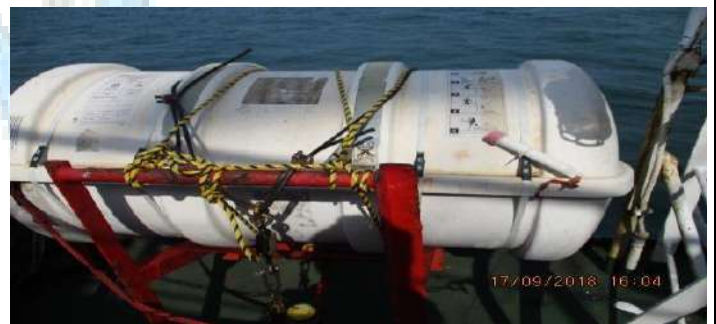
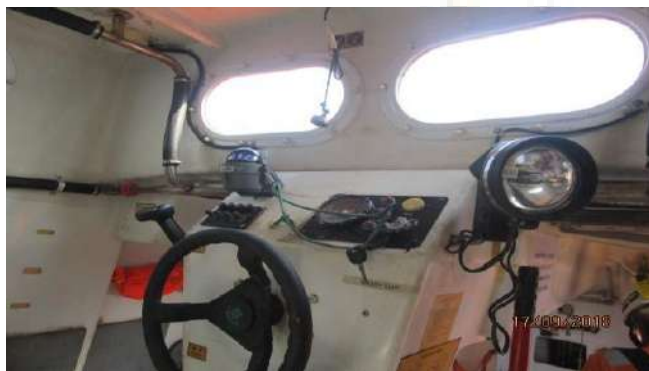
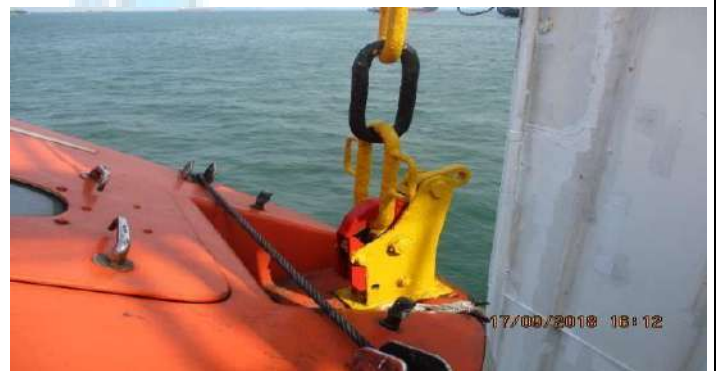
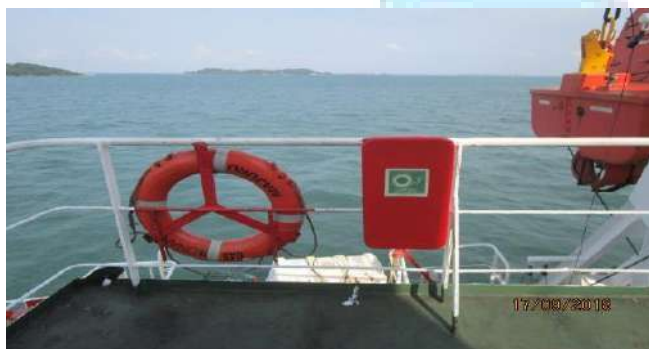
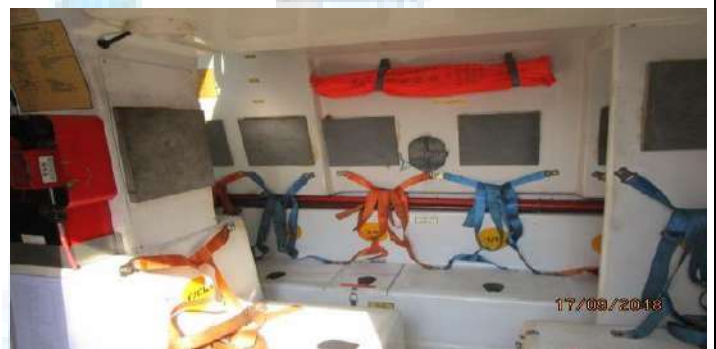
### 9.0 Life Saving Appliances

Lifesaving appliances provided for 24 persons. Vessel is provided with totally enclosed Lifeboats for 25 persons on Port & STBD side. There are two life rafts each 25 person's

capacity on either side. All of them appeared well maintained. All other Lifesaving appliances in addition to the above appeared well maintained

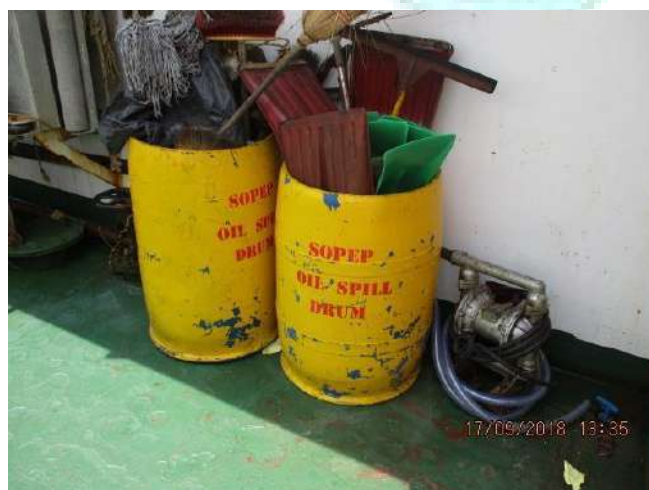
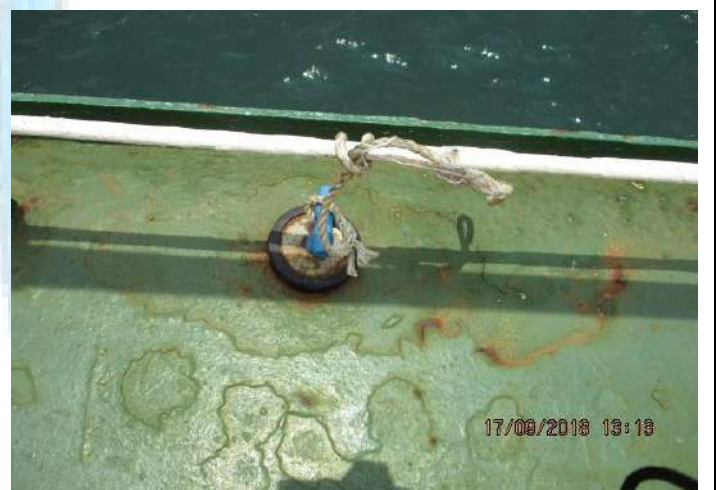
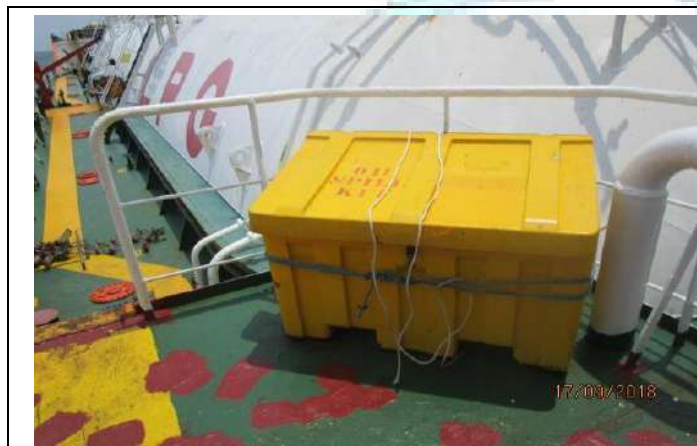
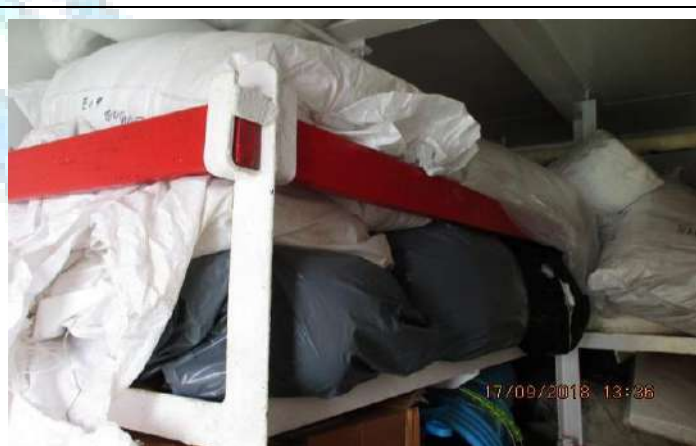
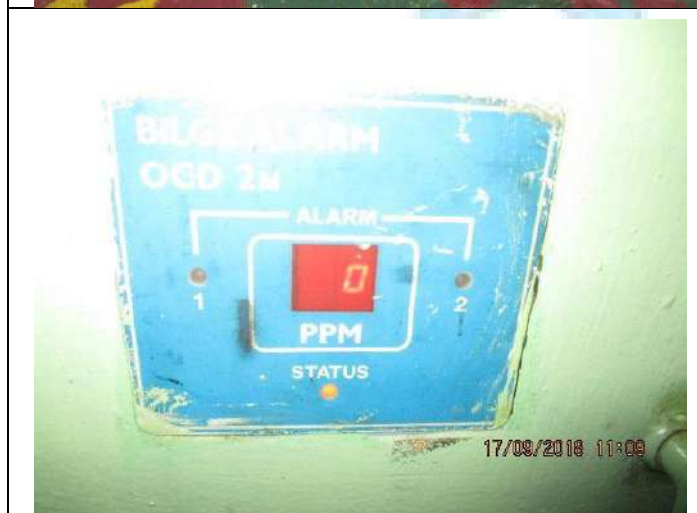
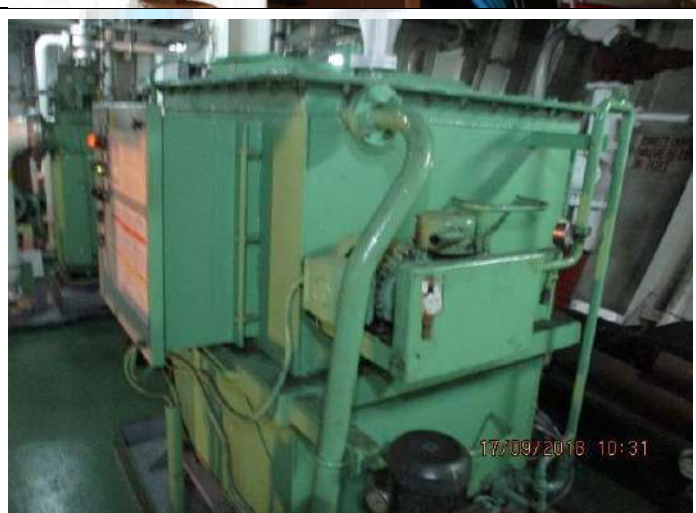
### 10 Environment Protection

SOPEP inventory is maintained in order. Good bunker plan is in place. Designated oil residue tanks are FO/ LO sludge tanks, Scavenge drain tank & waste oil tank for Incinerator with a total capacity of 9.3 cum. Oily bilge separator reportedly in good working order. Incinerator is reported working. Ships is provided with Bilge Holding tank of capacity 7.08 cum.
