PRE-PURCHASE ASSESSMENT

FINAL REPORT

TANKER (OIL/CHEMICAL)

MT SINOTECH MARINE

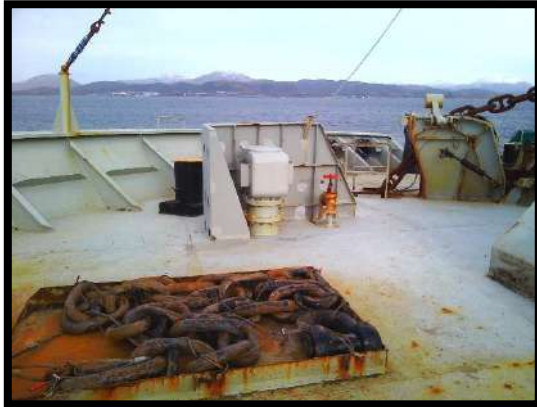
Forecastle & Poop Deck

- Mooring arrangement and deck coating have loose rust, but last maintenance have been not done accordingly

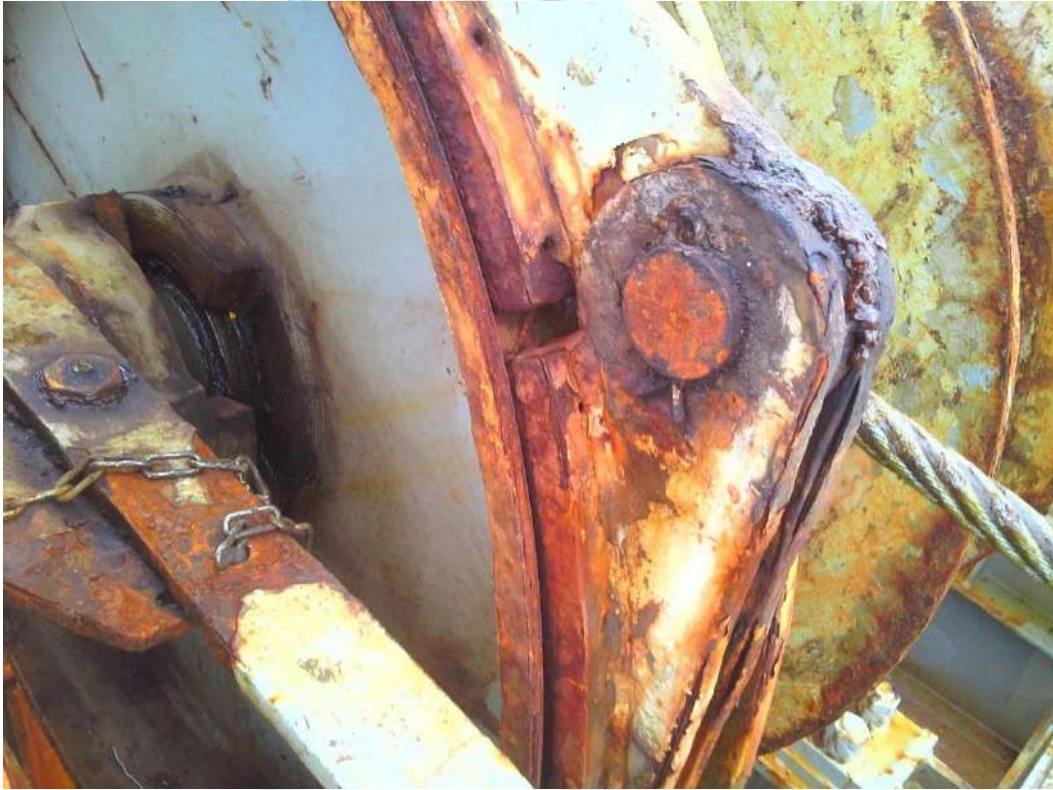
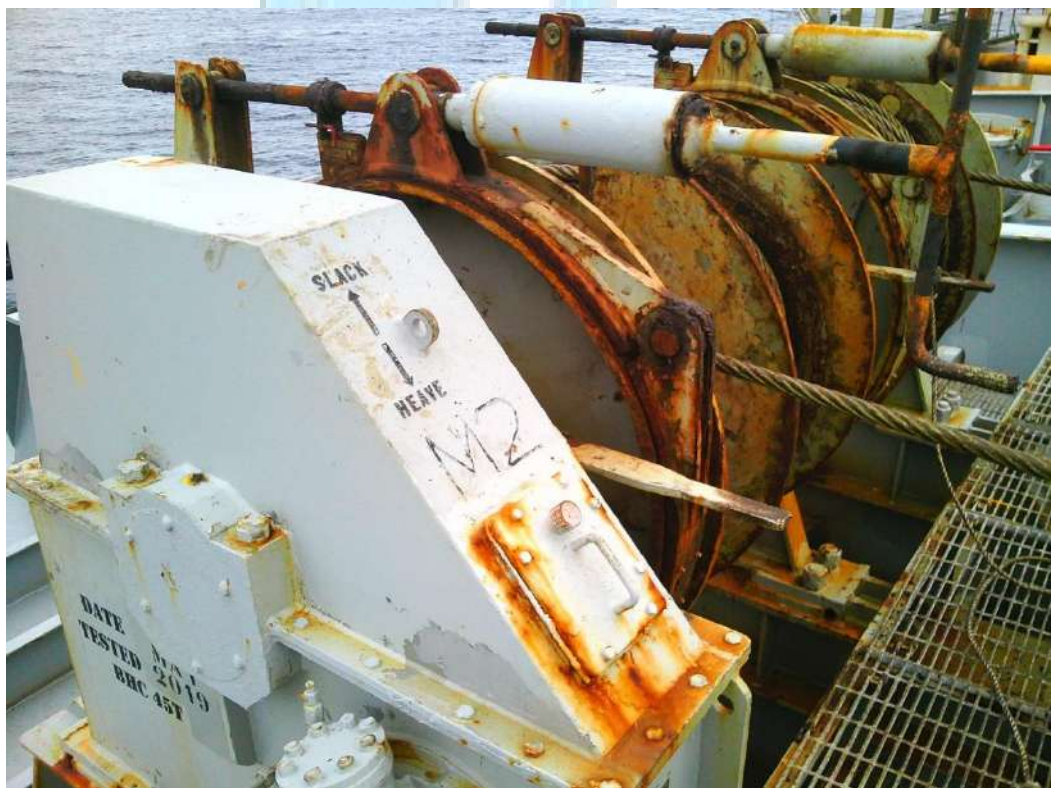
Immediate Concerns

Severity	Description	Action-Timeline	Approx. Cost US\$
Significant	Shipside external hull paint damages	6	300,000.00
Significant	Full deck areas are having scattered rust. Regular maintenance sighted.	6	200,000.00
Significant	Hard rust found in all hatch bulkheads from tank top to about 10 meters vertical height.	6	
Significant	All Australian ladders including railings are rusted moderately	6	10,000.00
Critical	All fairleads are ceased	6	
Significant	There is a dent of about 2 cm. in the forecastle deck in front of port hose pipe.	6	
Significant	All mooring winches, windlass is rusted moderately	6	20,000.00
Critical	Moderate Hydraulic leakage noticed from Fwd. stbd. mooring winch, Hyd. power pack unit in the forecastle store, Ram of Hatch #4 (Port side).	6	15,000.00
Significant	L/B davit found rusted.	6
