PRE-PURCHASE ASSESSMENT
PRELIMINARY REPORT
MT SINOTECH MARINE
(OIL / CHEMICAL)

IMO NO.	8888888888
Port of Registry	BERGEN
Year of Built	MARCH 2013
Builder Yard	STX OFFSHORE & SHIPBUILDING/KOREA
Classification	DNV – GL
Vessel State	LOADING CARGO
Date of Inspection	15/02/2020
Port of Inspection	MONGSTAD / NORWAY
Inspection Company	SINOTECH MARINE
Inspection Type	PREPURCHASE INSPECTION
Client	CONFIDENCIAL

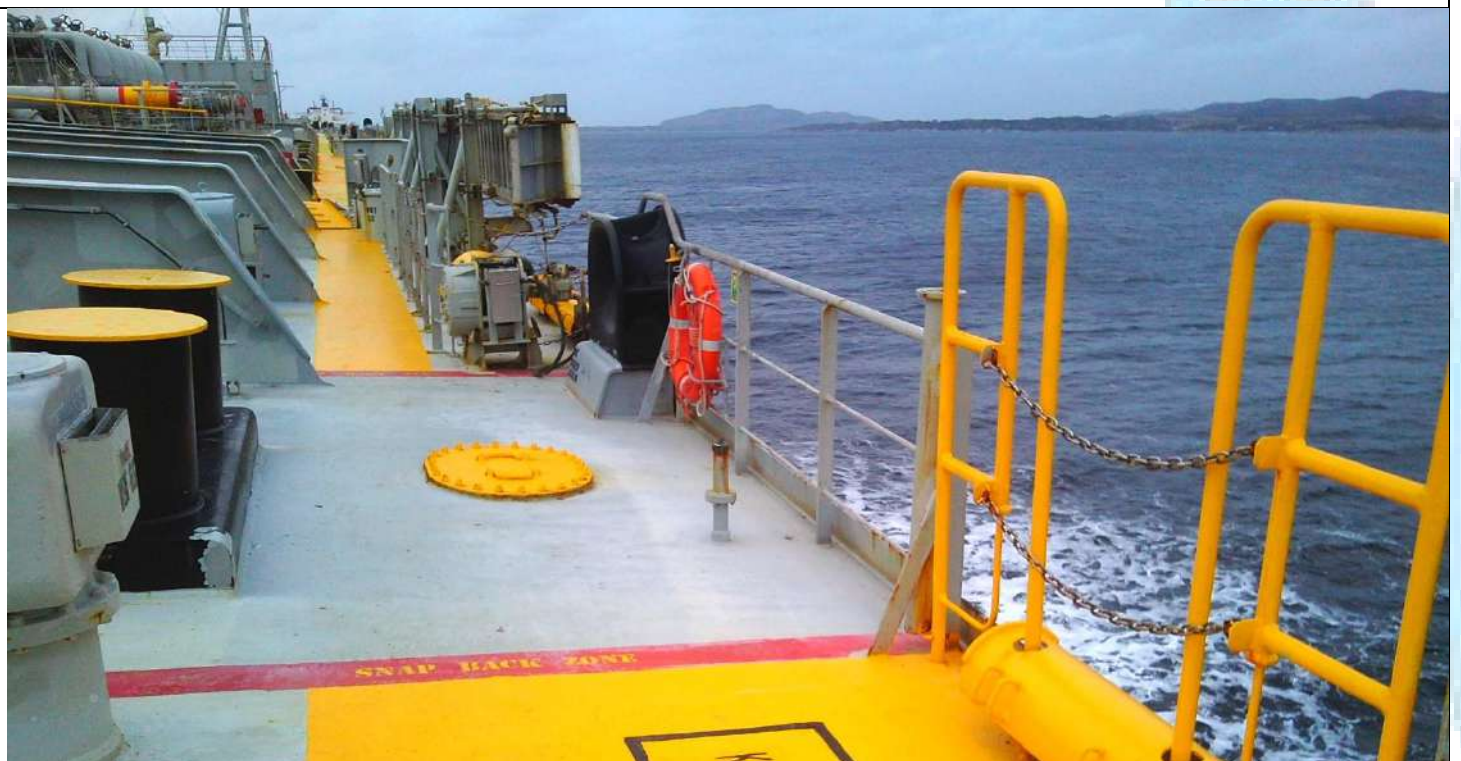
MAIN DECK STBD

THERE ARE SIGNIFICANT MARKS FOR FENDERS AND HULL HAVE LOOSE RUST ON PORT AFT SIDE. MAIN DECK, QUALITY OF LAST PAINT IS VERY POOR AND IN MIDSHIP THERE ARE PITTING AND CORRODED SPACES
