# PRE-PURCHASE ASSESSMENT PRELIMINARY REPORT MV SINOTECH MARINE (REEFER CARRIER)

IMO NO.	3333333	1000
Port of Registry	PANAMA	
Year of Built	30/04/1985	
Builder Yard	APPLEDORE, UK	
Classification	LLOYD'S REGISTER OF SHIPPING	
Vessel State	UNLOADING FROZEN FISH	
Date of Inspection	21-22 FEB 2020	
Port of Inspection	KLAIPEDA	
Inspection Company	SINOTECH MARINE	
Inspection Type	PREPURCHASE INSPECTION	
Client	CONFIDENCIAL

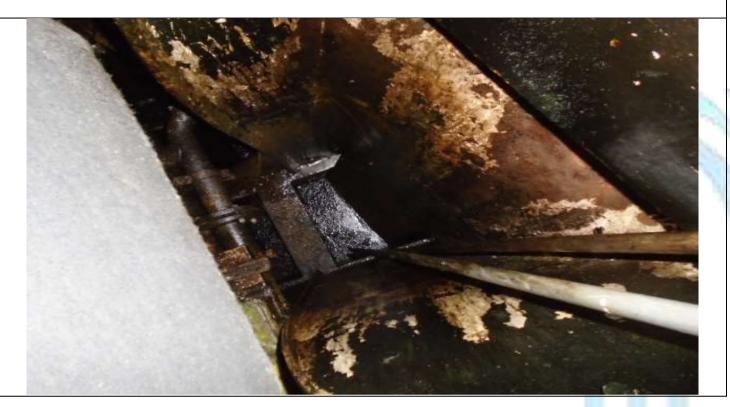
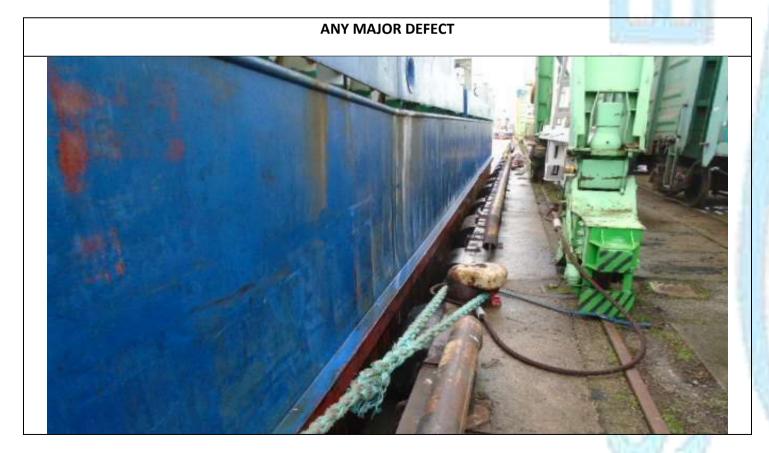
### ANY MAJOR DEFECT

ITEM	YES/ NO	COMMENT
1	Any visible major defect or damage to Hull or Machineries?	Yes	Severe Rib Caging and caving in of starboard shipside noticed
2	Is Ballast Water Treatment System Installed?	No	
3	Any outstanding condition of Class or Memoranda?	No	RELEASE
4	Whether last bottom survey was done in Dry-dock?	Yes	01/06/2017
5	Whether Docking survey due in next 2 years?	Yes	Yes, due in July 2020
6	Any major capital expenditure due in next 1 year?	Yes	Yes Drydocking/ Special Survey due in July 2020
7	Any PSC detention in last 5 years?	No	
8	Any change of ISM manager or Ship ownership in last 5 years?	No	
9	Any change of Classification society in last 5 years?	No	
10	Whether ECDIS fitted as primary means of Navigation?	No	Paper Charts in use. One ECDIS fitted for reference only.
11	Normal Cargo Crane operation witnessed?	Yes	Shore Cranes in Use.
12	Are electronic Inbricators fitted for M/E Cylinder Lubrication?	No

THERE IS AN IMMEDIATELY STRUCTURAL CONCERN THAT THE SEVERELY CAVED AND RIB CAGED PORT/STARBOARD SHIPSIDE MOSTLY TOPSIDE BE CROPPED AND RENEWED AS DEEMED NECESSARY.
